MARINE INVESTIGATION REPORT  
M97W0044

EXPLOSION AND FIRE ON BOARD  
THE OPEN HERRING-SKIFF "SHA 122"  
COMOX SMALL CRAFT HARBOUR, BRITISH COLUMBIA  
23 MARCH 1997

Report Number M97W0044

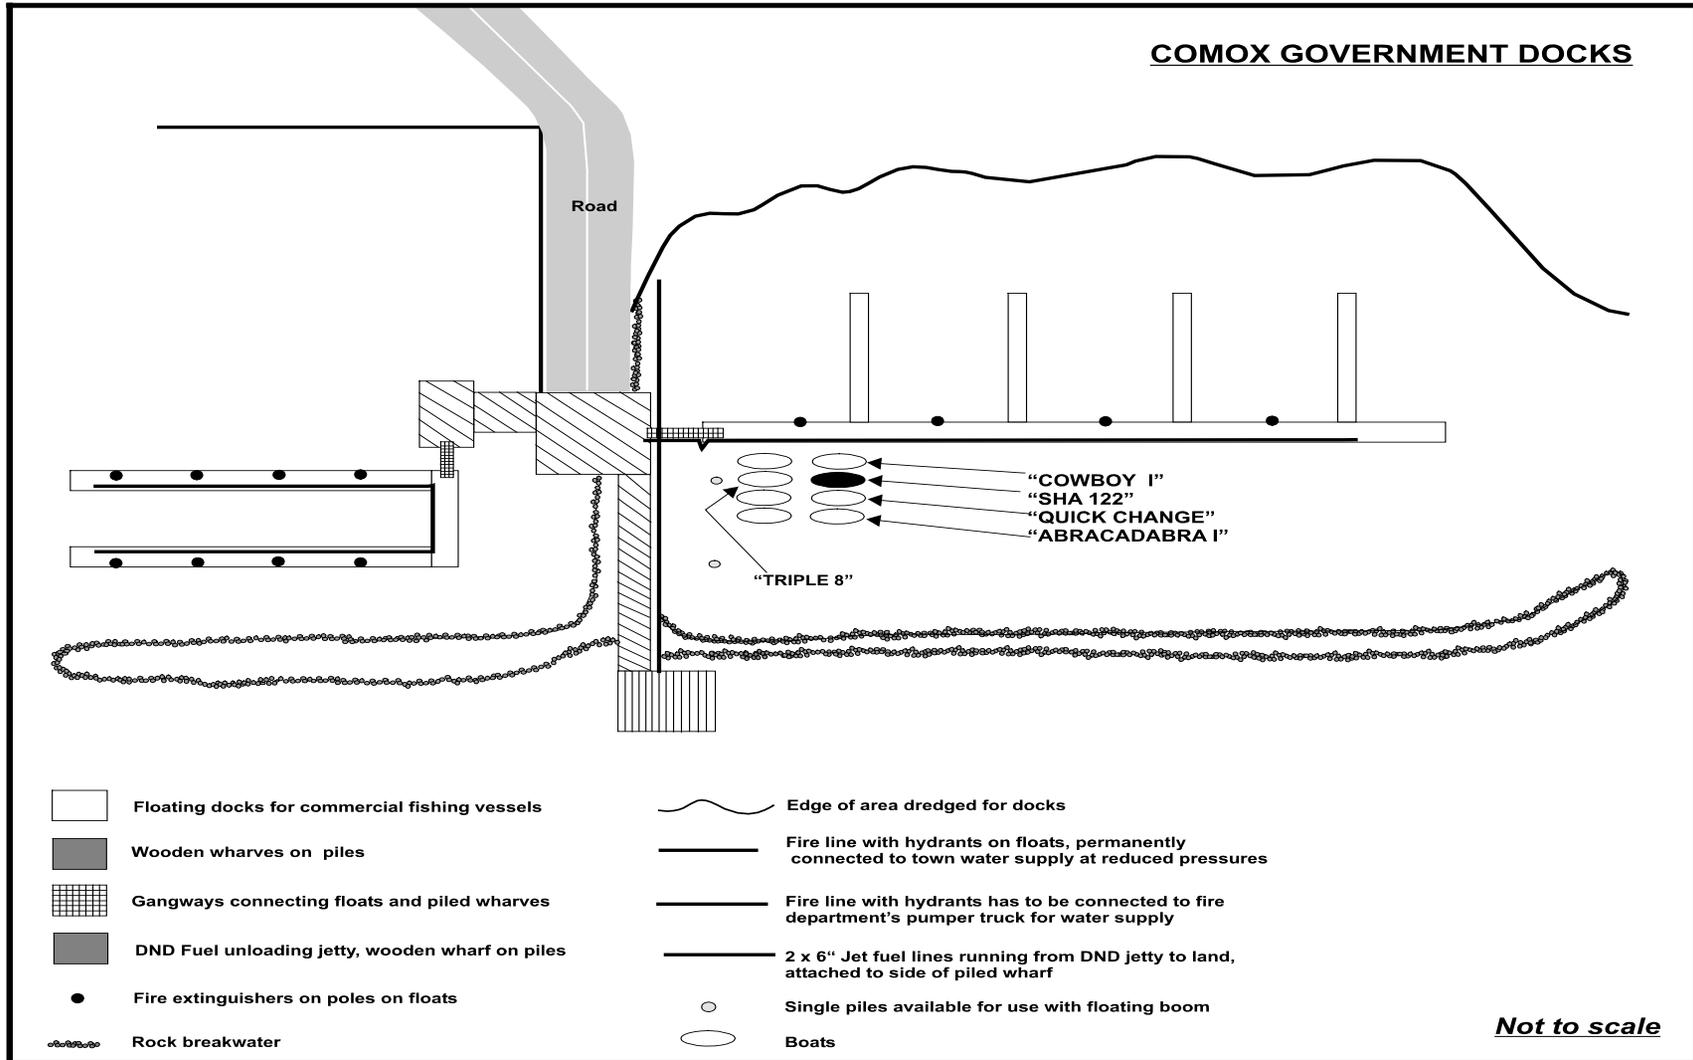
*Appendix A - Sketch of the Accident Area*

This row was the second row from the piled wooden wharf running from the shore to the Department of National Defence (DND) fuel wharf (Appendix “A”). In the first row and directly ahead of the “SHA 122” was another fishing vessel, the “TRIPLE 8”. The wooden wharf, running out to the DND wharf, carries two exposed six-inch fuel lines for supplying the airbase with aviation jet fuels “A” and “B”.

The foremost concern was to keep the fiercely burning "SHA 122" away from the wooden wharf fitted with the jet fuel lines, as the south-easterly wind tried to push the vessel downwind onto the wharf. There is no boom or restraining chain to keep vessels away from the wharf, although there are two free-standing piles that could be used for holding a floating boom or chains.

High Water at Comox was predicted to be 4.23m at 1723 on 23 March, immediately before the explosion. The high tide brought the fishing vessel up to a level where it could have struck the fuel lines, mounted externally to the walkway, which were very exposed.

6. The piled wooden wharf, running from the shore to the DND fuel wharf, has no protection from vessels either drifting or driven down onto it from the south-east. The exposed jet fuel lines on the east side of the wharf are in danger of being fractured or gashed by vessels at high tides.

six-inch jet fuel lines. The lack of a floating boom or chain to prevent vessels from approaching the wooden wharf places the six-inch diameter aviation jet "A" and "B" fuel lines at risk. A floating boom could be easily laid against the two free-standing piles located to the east of the wooden wharf.

The harbour master of the Comox Small Craft Harbour requested that a floating boom be installed to prevent any vessel from contacting the wooden wharf. This request was acted upon by Small Craft Harbours and a

floating boom now protects the jet fuel lines on the Department of National Defence wharf.
