MARINE INVESTIGATION REPORT
M01M0017

CONTAINER FIRE

CONTAINER VESSEL *KITANO*
OFF CHEBUCTO HEAD, NOVA SCOTIA
22 MARCH 2001

Report Number M01M0017

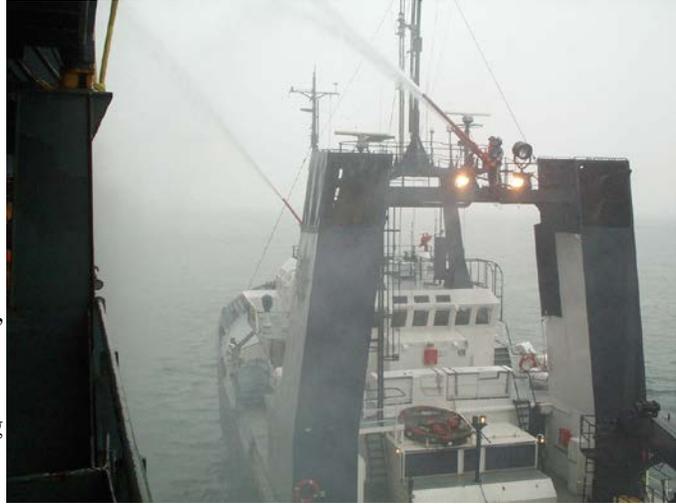
With the vessel safely anchored, a four-man military fire team with thermal imaging equipment boarded the vessel to carry out a fire assessment. Shortly after the military fire assessment team boarded the vessel, a seven-person salvage fire team also boarded in order to assist with the firefighting efforts. At 1655, the *Ryan Leet* came alongside the *Kitano* and started to fight the fire in container 300986 using two fire monitors. At 1700, the vessel's crew was stood down and relieved by the seven firefighters from the salvage company. At 1810, the vessel's crew rejoined the fire fighting effort and at 1940, the harbour pilot/liaison was relieved by his replacement. At 2050 the fire in container 300986 was confirmed extinguished. The final container (301186) was opened up at 2115, and one hour later at 2215, the last of the four (loaded) containers was confirmed extinguished. With the firefighting efforts now complete, the firefighters as well as the *Ryan Leet* remained on scene to monitor the situation and relieve the vessel's own crew.

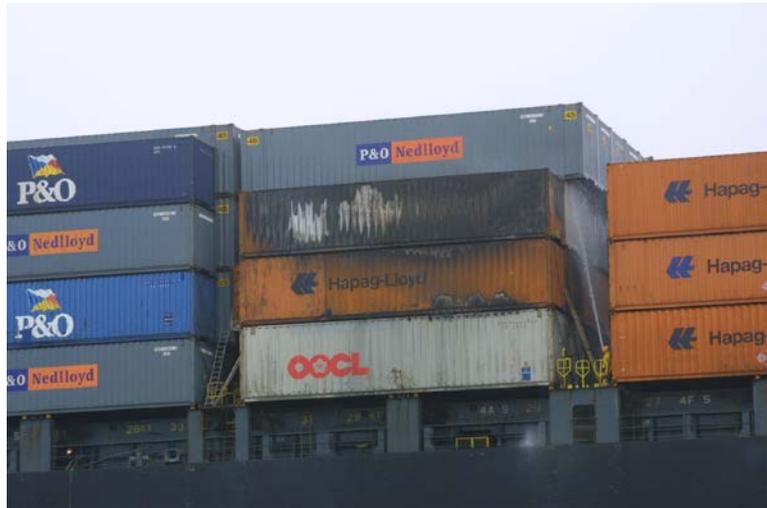
On the morning of 24 March 2001, the *Kitano* was cleared by VTS to proceed to the container pier in Fairview Cove. At 0750, the vessel weighed anchor and under the escort of the *Ryan Leet* and two harbour tugs, proceeded to the Ceres container terminal. At 0940, the *Kitano* was secured alongside and the damaged containers as well as those adjacent to the fire were removed and inspected. Crews from both the Halifax Regional Municipality (HRM) Fire Service and the salvage company stood by the vessel until the following day as normal cargo operations resumed. On the morning of 26 March 2001, after discharging cargo destined for the port, the *Kitano* departed Halifax.

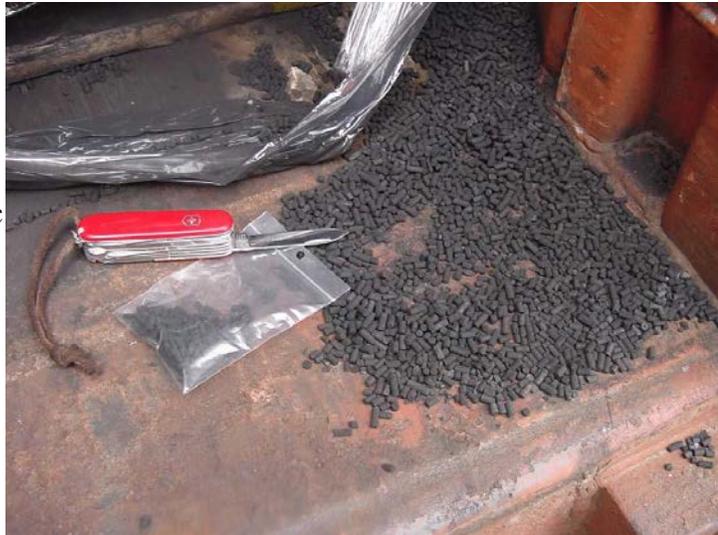
The container in which the fire started contained 14 - 115 kg drums and 288 -44 kg open mesh bags of activated carbon pellets impregnated with potassium hydroxide (caustic potash). The bags of carbon pellets were bundled and plastic wrapped onto 14 wooden pallets. The activated carbon pellets are commonly used for the desulphurisation of gases and the removal of acidic contaminants such as hydrogen sulfide, hydrogen chloride and mercaptans.

At the outset of the occurrence, the container containing the GC IPH activated carbon pellets was identified as the only unit indicating signs of smoke and extreme heat. In addition glowing carbon pellets were observed falling from the wooden bottom of the container onto another container directly below. A preliminary boundary survey of all the adjacent containers revealed no abnormalities. The container with the activated carbon pellets was the source of the fire.

1. The source of the fire was container 301184 which contained a cargo of GC IPH activated carbon pellets.
2. The source of ignition of the fire could not be determined.
