# AIR TRANSPORTATION SAFETY INVESTIGATION REPORT A23P0130

## LOSS OF CONTROL AND COLLISION WITH TERRAIN

SkyQuest Aviation Ltd.  
Piper Aircraft Corp. PA-34-200 (Seneca), C-GTYH  
Chilliwack Airport (CYCW), British Columbia  
06 October 2023

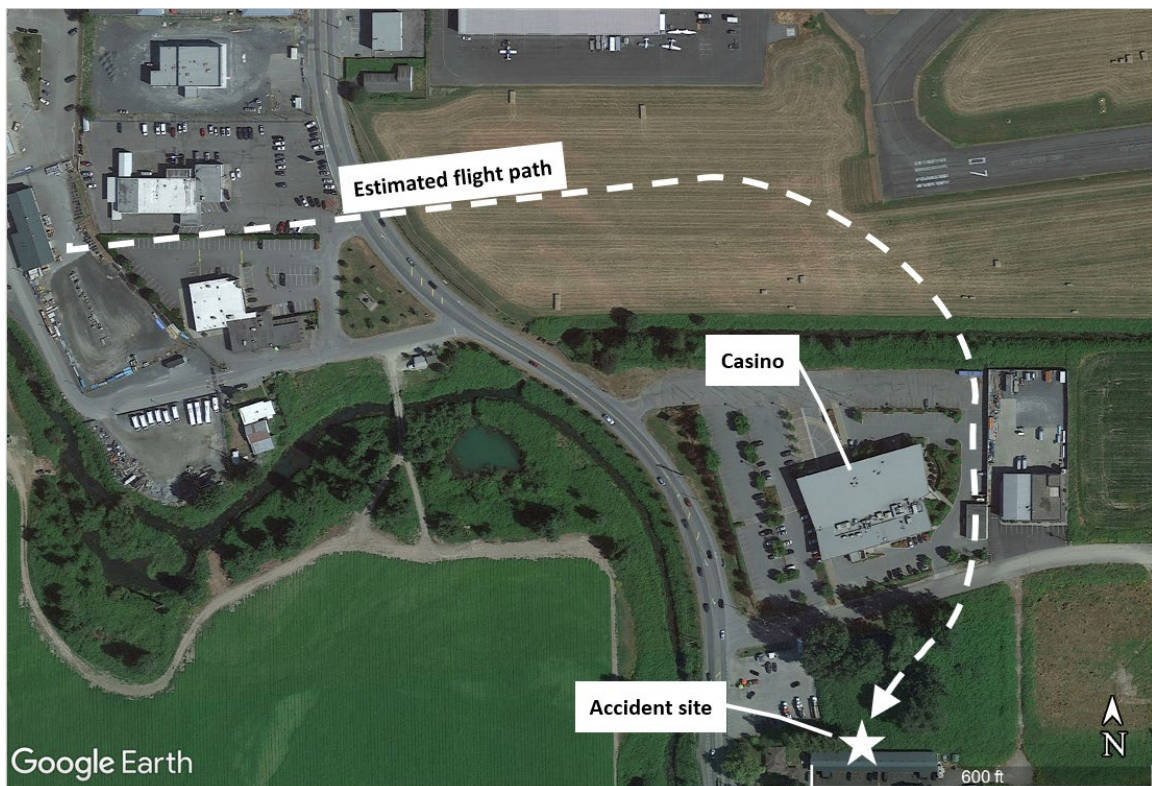
Figure 1. The aircraft's estimated flight path based on dashcam video (Source: Google Earth, with TSB annotations)

The aircraft levelled off below 100 feet above ground level (AGL) while aligned with the runway; then, before reaching the runway threshold, it banked and turned right. The bank angle continued to increase past 90° while the aircraft's heading changed toward a southerly direction, and the pitch decreased toward a nose-down attitude. At 1359,<sup>1</sup> the aircraft impacted the ground near a casino in a close-to-inverted and nose-low attitude.

There was no flight-path data available from the aircraft's avionics, and there was no radar information recorded of the aircraft's activity at CYCW. However, a dashcam video camera from a vehicle passing the airport recorded the last moments of the flight.

The dashcam video and post-accident wreckage examination are consistent with the aircraft entering a minimum control speed ( $V_{MC}$ )<sup>3</sup> roll before the collision with terrain. A  $V_{MC}$  roll occurs when there is an asymmetrical power situation and the aircraft's speed falls below  $V_{MC}$ . In this scenario, the aircraft will begin to yaw and roll toward the low-thrust-producing engine because there is insufficient yaw control available to counter the thrust produced by the operating engine.
