# RAIL TRANSPORTATION SAFETY INVESTIGATION REPORT R23D0108

## MAIN TRACK COLLISION AND DERAILMENT

Canadian National Railway Company freight train X37631-20 and  
Réseau de transport métropolitain (exo) commuter train EXO 1212  
Mile 135.89, St-Laurent Subdivision  
Montréal, Quebec  
21 November 2023

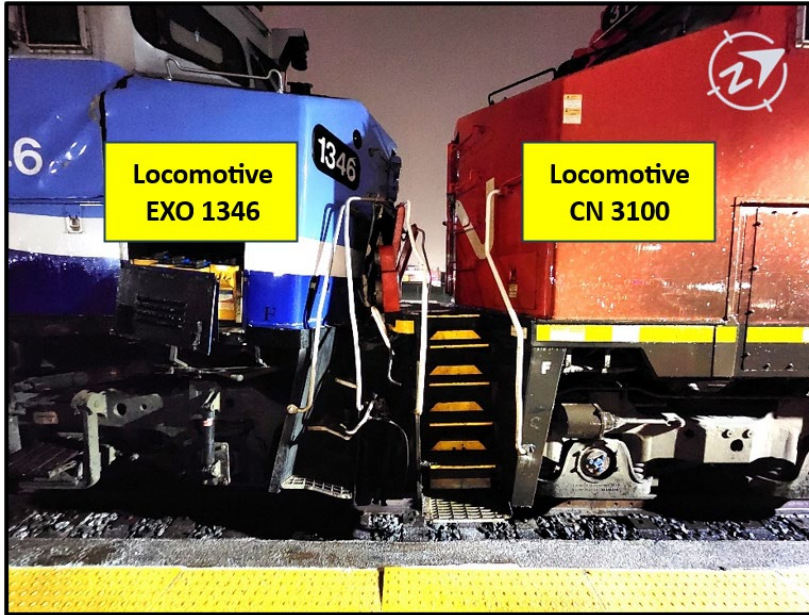
Figure 3. Damage to the front ends of locomotives EXO 1346 and CN 3100  
(Source: TSB)

The coupler arrangements between the CN 3100 and CN 3201 locomotives of train CN 376 broke on impact, causing the 2 locomotives to separate. Locomotive CN 3100 slammed into the locomotive of train EXO 1212 and pushed this train southward for about 150 feet. A truck on car EXO 3062 derailed. Locomotives CN 3100 and CN 3201 sustained damage mainly to their coupler systems, while locomotive EXO 1346 and car EXO 3062 on

train EXO 1212 were structurally damaged to the point where they were considered total losses (figures 3 and 4).

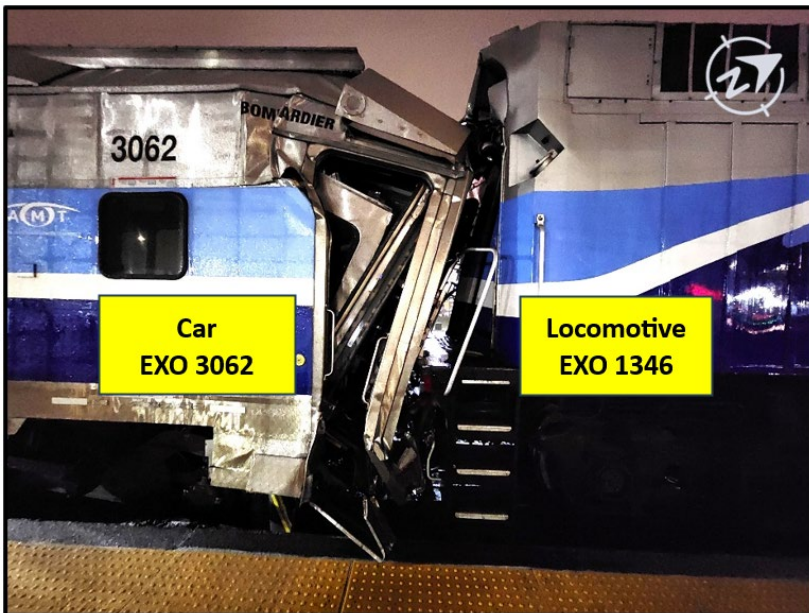
Figure 4. Damage to car EXO 3062 and the rear portion of locomotive EXO 1346  
(Source: TSB)

Car EXO 3062, which was coupled to locomotive EXO 1346, suffered damage to its vestibule and intermediate areas when the rear portion of locomotive EXO 1346 plowed into its

A end,<sup>8</sup> causing the wheels of the 1st axle to derail. The multilevel area did not suffer any visible deformation, and all the windows remained intact and fixed to their frames.

In the collision, locomotive EXO 1346 and the 1st passenger car (EXO 3062) sustained the most deformations. The damage to car EXO 3062 was limited to the boarding area (vestibule and intermediate areas). The car's structure performed as designed: the multilevel central area, designated for passengers, was not visibly deformed, and all the car's windows remained intact.

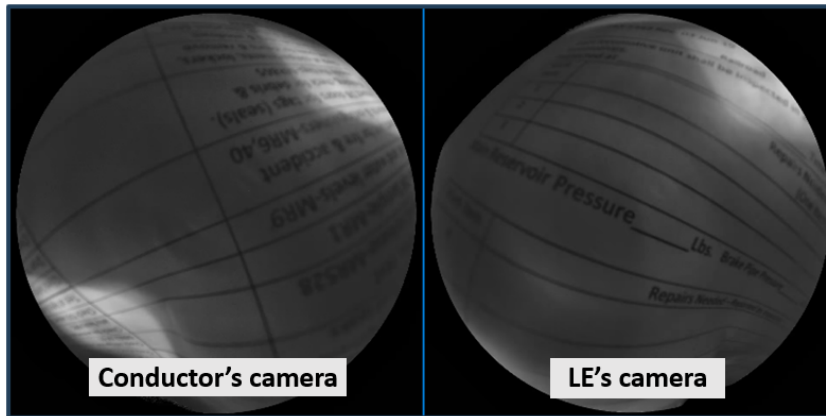
Figure 6. Obstructed view from the 2 cameras in the cab of the locomotive CN 3100 (Source: TSB)

When analyzing the LVVR<sup>11</sup> data from the CN 3100 locomotive, the TSB found that the 2 cameras inside the cab were obstructed by sheets of paper (Figure 6).<sup>12</sup> However, the voice recording was unaffected by the obstruction of the cameras, and conversations between crew members were still audible.

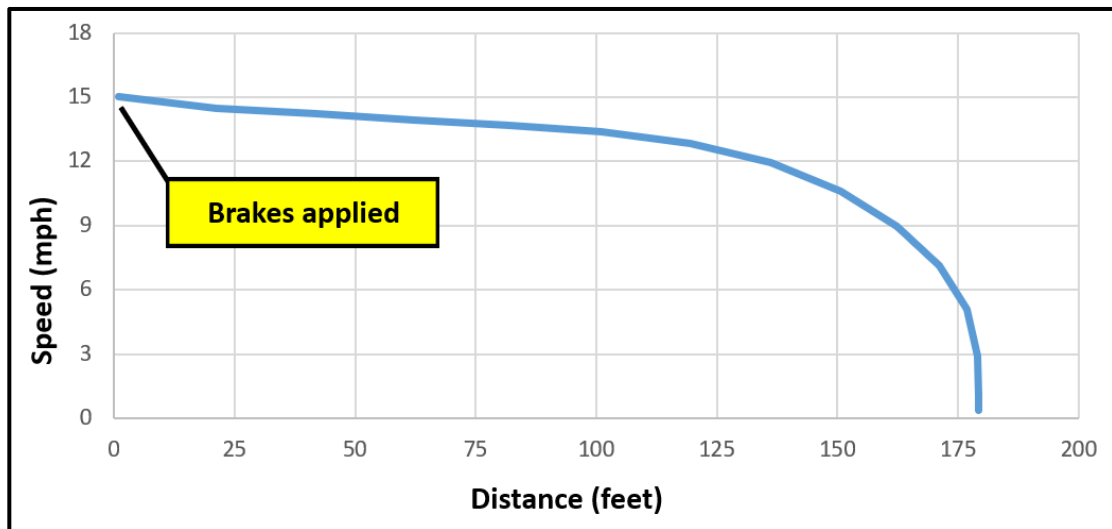
Figure 9. Exemplar train deceleration curve from simulations (Source: TSB)

The simulations showed that the distance required to stop the exemplar train would have been less than 200 feet.
