# AIR TRANSPORTATION SAFETY INVESTIGATION REPORT A25W0058

## LOSS OF CONTROL ON TAKEOFF

Privately registered  
Van's Aircraft, Inc. RV-14A (amateur-built aircraft), C-GXIV  
Calgary/Springbank Airport (CYBW), Alberta  
16 May 2025

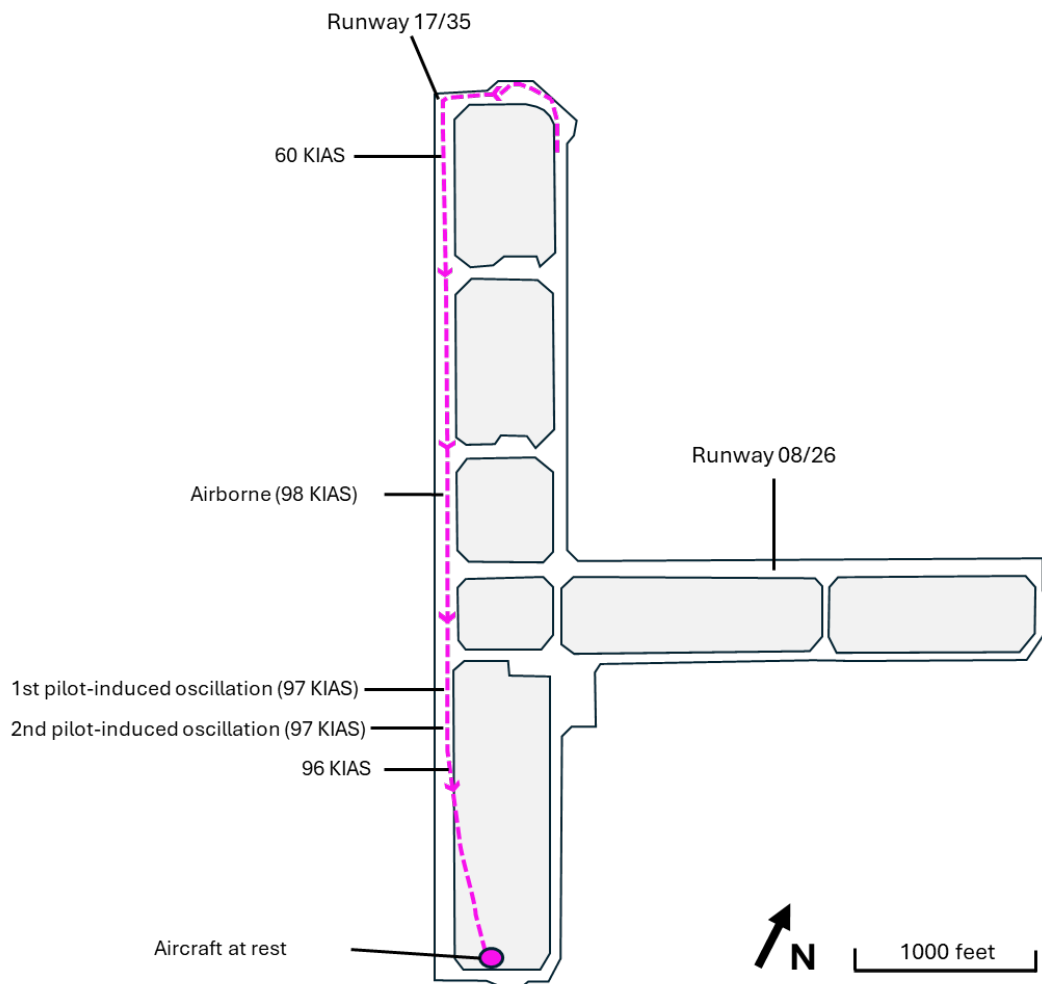
During the 2nd attempt, the aircraft gained approximately 10 to 20 feet of height and reached a maximum speed of 98.4 KIAS. When the aircraft passed the threshold for Runway 08, and at an airspeed of 97 KIAS, the pilot aborted the takeoff because he again perceived the aircraft performance to be lower than anticipated. The aircraft descended and contacted Runway 17, nose landing gear first. The aircraft subsequently bounced, became airborne again, entered a pilot-induced oscillation (PIO),<sup>3</sup> and drifted to the left of the paved runway surface. The aircraft descended and impacted the grass area on the left (east) side of Runway 17 (Figure 1).

**Figure 1. Occurrence aircraft's flight path (dashed line), with sequence of events and approximate airspeeds indicated (Source: TSB)**

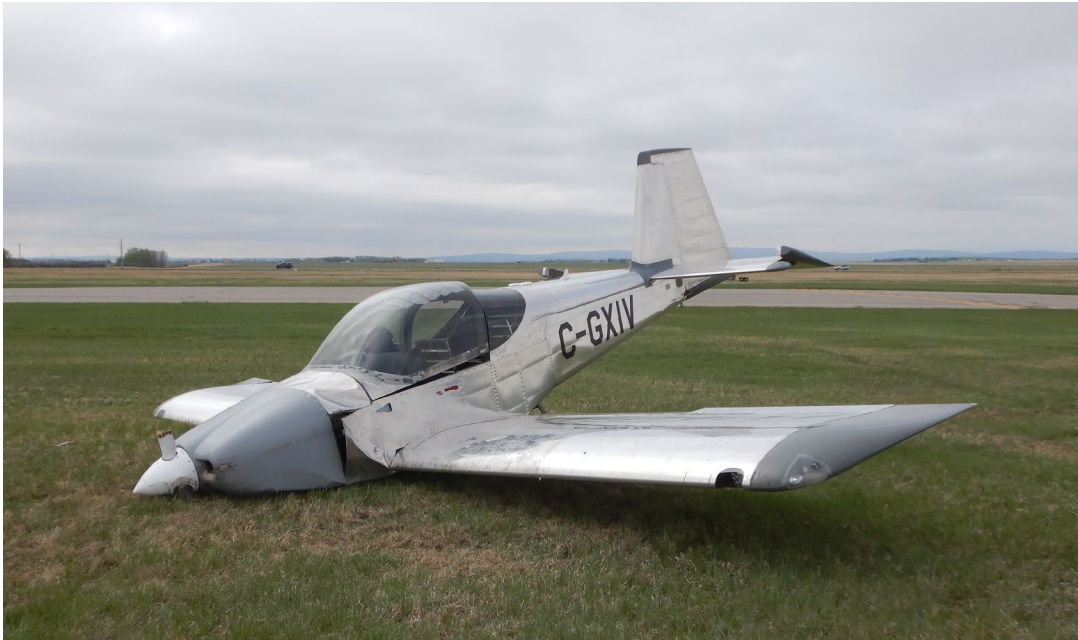
The right main landing gear broke free from the aircraft and impacted the right horizontal stabilizer. The left main landing gear collapsed and folded aft under the fuselage, and the nose landing gear collapsed aft. The propeller contacted the ground, and all 3 propeller blades broke off (Figure 2). The firewall area of the forward fuselage also sustained significant damage.

Figure 2. Post-accident view of occurrence aircraft, looking west (Source: TSB)

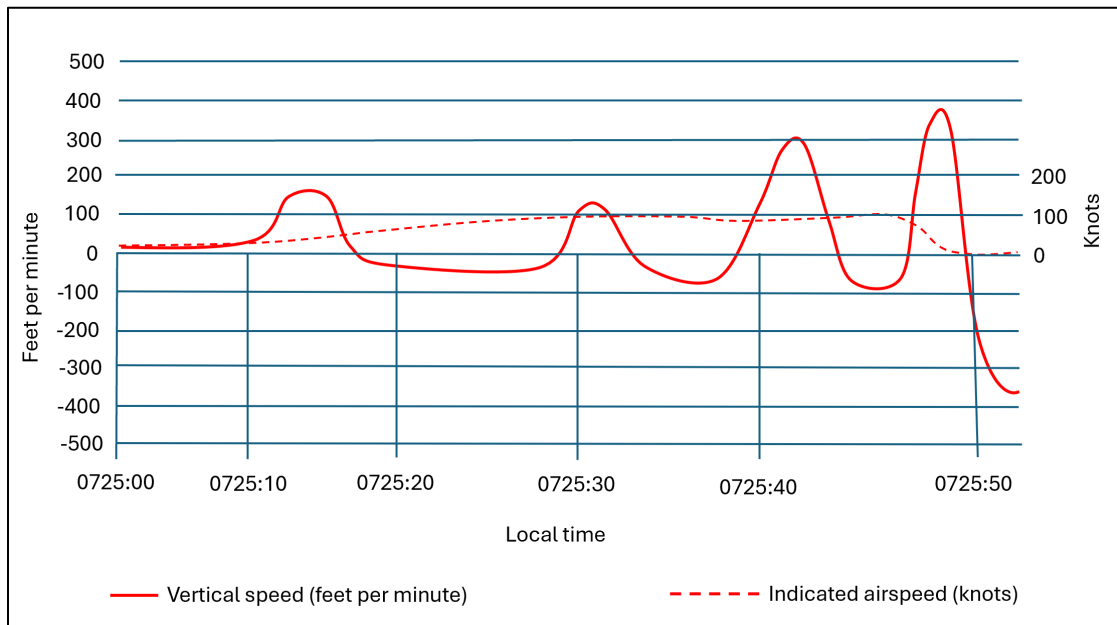
PIO, also known as porpoising, can present a notable challenge to pilots during the landing phase of a flight. As explained by the U.S. Federal Aviation Administration (FAA) in its *Airplane Flying Handbook*, "[i]n a bounced landing that is improperly recovered, the airplane comes in nose first, initiating a series of motions imitating the jumps and dives of a porpoise."<sup>7</sup> As was the case in the occurrence flight (Figure 3), the series of oscillations involves an increase in amplitude.

Figure 3. Occurrence flight path data of the 2nd takeoff (Source: TSB)
