AIR TRANSPORTATION SAFETY INVESTIGATION REPORT A24C0042

ENGINE FAILURE AND FORCED LANDING

Kudlik Aviation Inc.
Pilatus PC-12/47, C-FKGE
Rankin Inlet Airport (CYRT), Nunavut, 5 NM E
07 May 2024

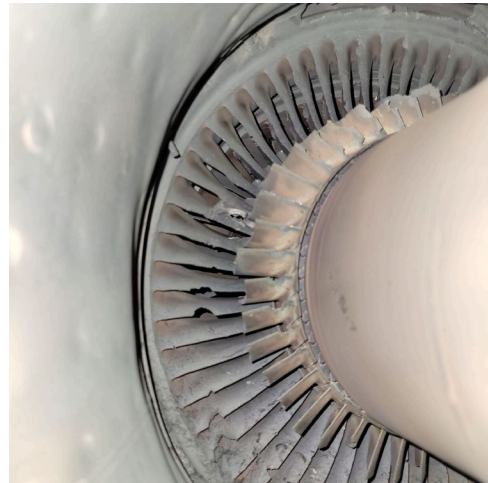
- The engine did not rupture and remained intact with the exception of the 2 power turbine stages, in which all the blades had experienced midspan fractures (Figure 2).
- The majority of the blade fragments exited through the exhaust ducts.
- The exhaust ducts and power turbine vane ring were heavily dented.
- The blade fragments did not appear to damage the aircraft's windscreen or fuselage.
- The compressor section turned freely and, along with the combustion section, presented no abnormalities.
- A borescope inspection of the engine revealed that 1 compressor turbine blade had a small piece of material missing from its trailing edge.
- The front engine (gearbox) magnetic chip detector plug was covered with metal contaminants.
- There were no observed oil or fuel leaks.

Figure 2. View of the occurrence aircraft's 2nd stage power turbine with broken blades when looking in through the exhaust duct (Source: TSB)
