AIR TRANSPORTATION SAFETY INVESTIGATION REPORT A25Q0051

LOSS OF CONTROL AND OVERTURN ON TAKEOFF

ETA Aviation & César Camp du Nord Inc.
De Havilland Aircraft of Canada Limited DHC-2 Mk. I (Beaver), C-FYNT
St-Mathias Water Aerodrome (CSV9), Quebec
02 May 2025

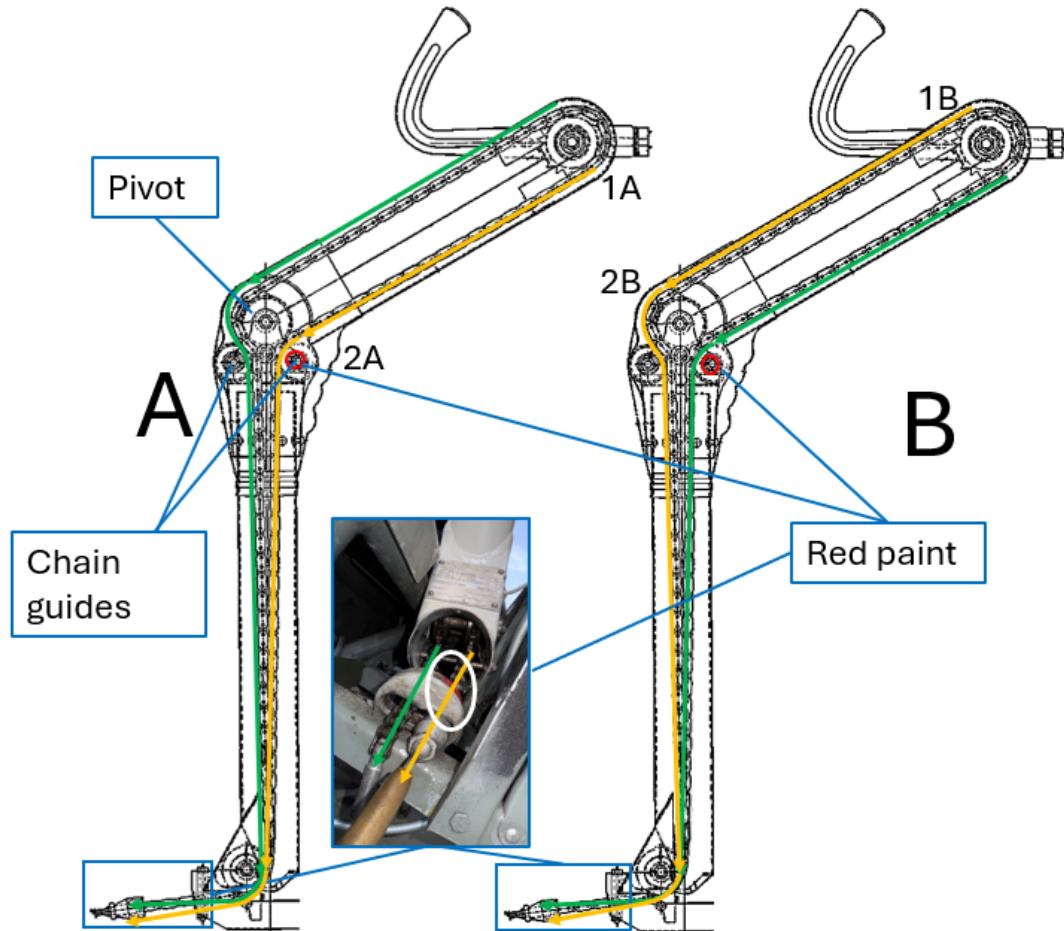
A more thorough examination of the wreckage determined that, during the recent maintenance work, the control column chain connected to the aileron system had been installed in the opposite direction to what was stipulated in the aircraft maintenance manual. Even though inspections had been carried out by the AME after the work and by the pilot before the

A warning in the aircraft maintenance manual⁵ indicates that the guide block at the base of the control column, where the chain comes out, is painted red on the side facing the front of the aircraft and the chain guide on the pilot's side below the pivot is also painted red. Therefore, when the chain is threaded (Figure 1, from point 1A to point 2A), the end of the chain that attaches to the front cable of the aileron system must pass through these 2 red marks.

However, when the chain was threaded, the aircraft maintenance manual was not consulted. The apprentice was therefore unaware of the warning about the use of the red paint to thread the chain, and he unknowingly threaded the chain in the opposite direction (Figure 1, point 1B to point 2B).

Figure 1. Illustration showing how the control column chain is threaded, viewed from the front to the back of the aircraft. Side A shows the aircraft manufacturer's instructions (1A to 2A). Side B shows what was done during the maintenance work (1B to 2B). The inset image shows the red paint mark on the guide block at the base of the control column. (Source of the drawings: Aircraft manufacturer, with TSB annotations. Source of the inset photo: Third party, with permission, and with TSB annotations)

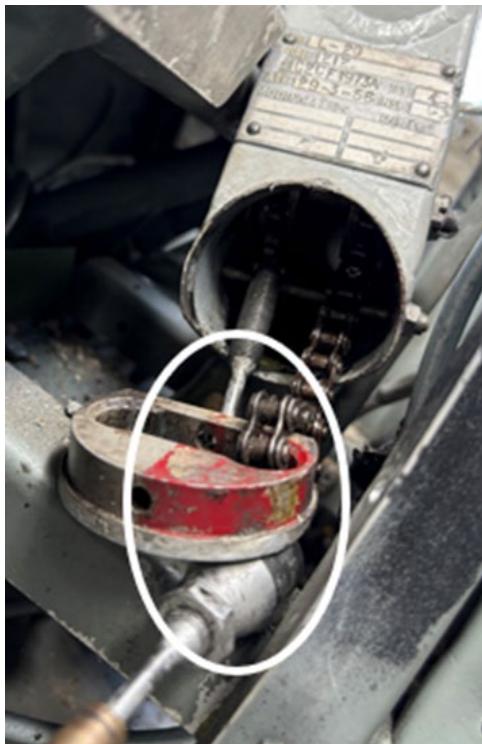
On the occurrence aircraft, the guide block at the base of the control column had a red paint mark (Figure 2).

Figure 2. Red paint on the inner surface of the guide block at the base of the control column (Source: Third party, with permission, and with TSB annotations)

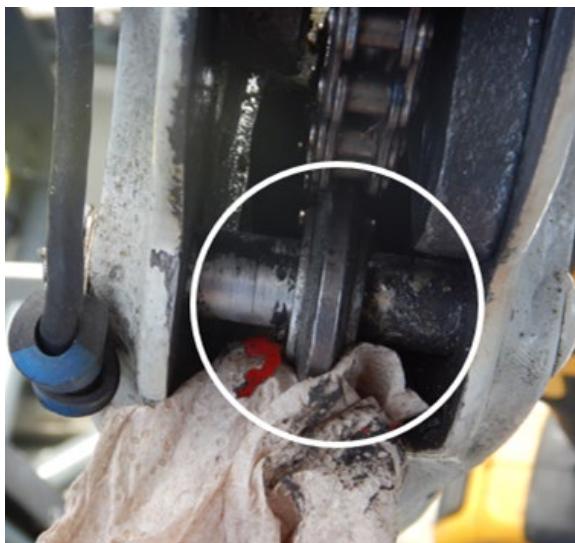
On the chain guide below the pivot point, grease was covering the spot that is normally painted red. When the grease was wiped off, very little red paint remained, and it flaked off easily (Figure 3). Other than the red paint marks, nothing in the design indicates the proper way to thread the chain or prevents the chain from being threaded the wrong way.

Figure 3. Red paint remaining on the chain guide at the control column pivot point once the grease was wiped off (Source: TSB)
