AVIATION INVESTIGATION REPORT A02C0079

**RISK OF COLLISION**

Nav Canada Winnipeg Area Control Centre - Prince Albert Sector Saskatoon, Saskatchewan 50 nm E 25 April 2002

## Report Number A02C0079

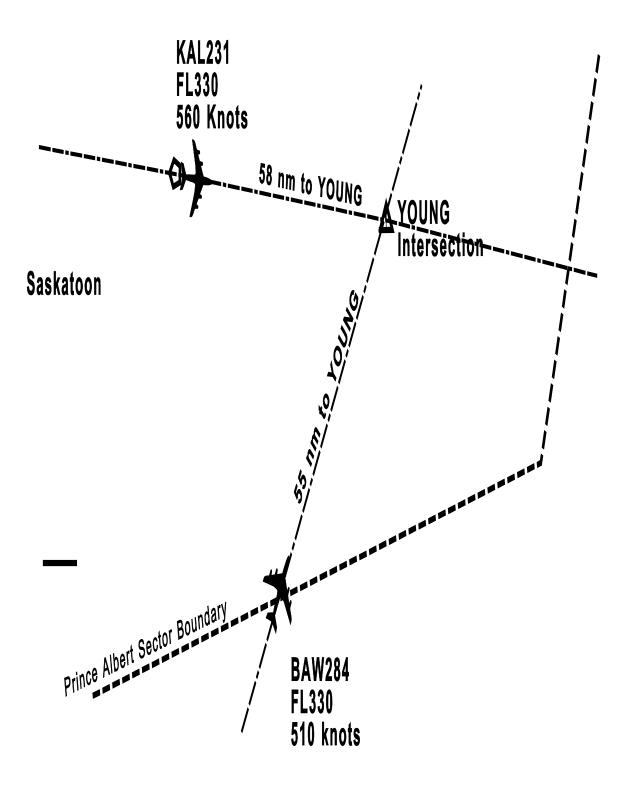
Appendix A - Route of Flight

At 2126, KAL231 passed the Saskatoon fix (see Appendix A). The PA sector controller calculated that KAL231 would cross the Yorkton fix at 2144 and then performed tasks involving three other aircraft. He did not check for conflicts between KAL231 and other aircraft.
