AVIATION INVESTIGATION REPORT

A05Q0208

TREE IMPACT WITHOUT LOSS OF CONTROL

CESSNA 172M C-GPUL

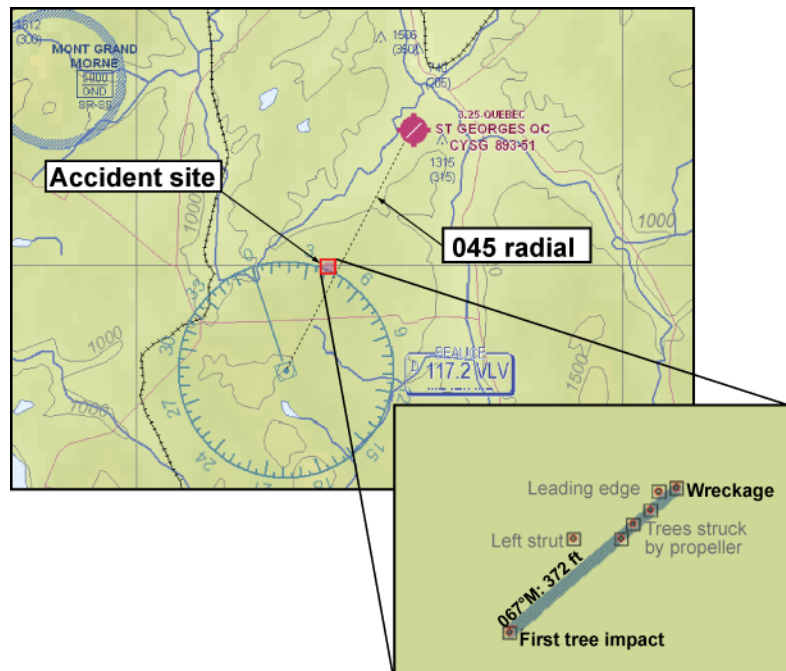
Figure 1. Accident site

The aircraft crashed in a forest clearing 30 miles east of the location where the wildlife protection officers in the aircraft were to rendezvous with those on the ground. The accident site is ½ mile northwest of the 045 radial for the VOR Runway 06 approach of the Saint-Georges aerodrome, about 6 nm southwest of the Saint-Georges aerodrome, and 5 nm northeast of the Beauce VOR (VLV) (see Figure 1). The accident site is at an elevation of 1350 feet asl, some 500 feet higher than the Saint-Georges aerodrome.

The aircraft flew over a field before striking the treetops at the edge of the wood. The aircraft's initial trajectory in the trees was 067°M. It entered the trees in cruise attitude. It started to break up on first contact with the trees and crashed in an inverted position in a clearing 372 feet from the point of first contact. The wreckage was partly destroyed by fire. It was not possible to determine precisely when the fuel-fed fire started. However, examination of the wreckage revealed that there was no in-flight fire.

Examination of the wreckage, systems and all components recovered revealed no faults that would have adversely affected control of the aircraft and no pre-impact failures or malfunctions. The engine was severely damaged by fire. The trees severed by the propeller and the impact marks on the leading edges of the blades indicate that the engine was functioning at the time of the crash. Examination of the flight controls could not establish the position of the flaps on impact. Examination of the seat-belts revealed that all occupants were buckled in. The buckles of the front seat shoulder harnesses were not attached to the seat-belt buckles.

The cockpit and cabin were so damaged by the impact and post-crash fire that the occupants' space was reduced almost to nil. Although the three occupants were wearing their seat-belts, the accident was not survivable.
