Air Transportation Safety Investigation Report A17C0147

COLLISION WITH TERRAIN

Piper PA-23-250 Aztec, C-FIPK
Baldur, Manitoba, 5 nm E
15 December 2017

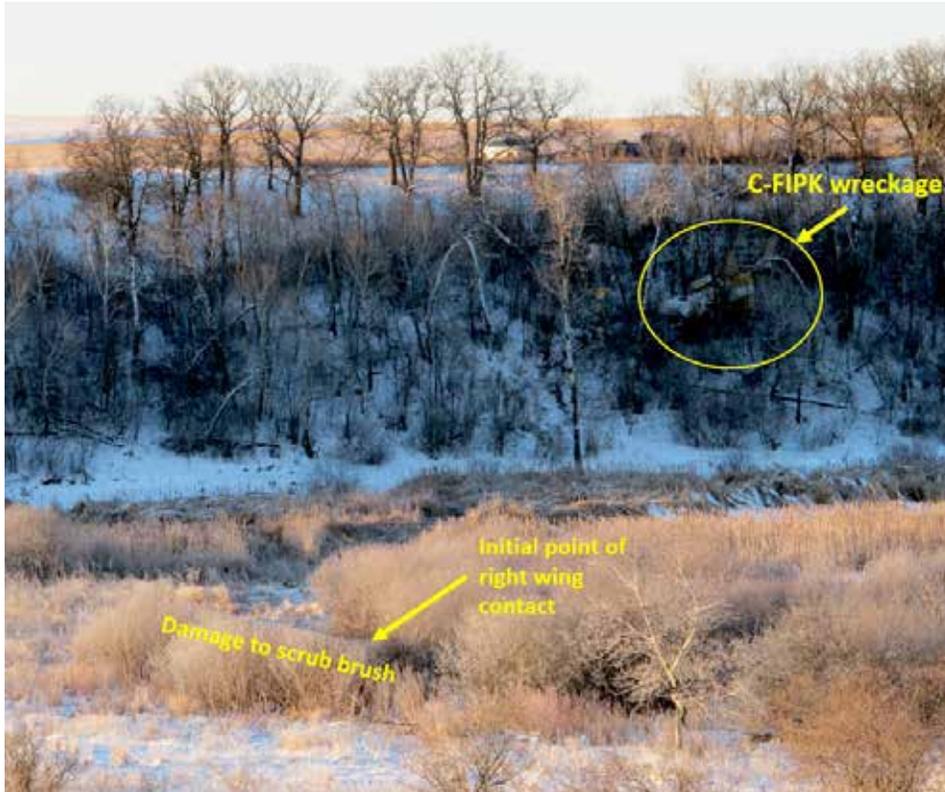
Figure 3. View of the initial impact site and wreckage

The right wing contacted scrub brush roughly 8 feet from the marsh surface (Figure 3). Damage to the scrub brush indicates that the aircraft was in a 5° descent while banking approximately 23° to the right.

The right wing-tip and fuel tank were torn away on contact with the frozen marsh. The aircraft travelled across the marsh for about 300 feet before colliding with the steeply rising tree-covered terrain on the southwest side of the valley. The left outer wing-panel had broken away after contacting a tree, at a height of about 15 feet, and lay on the right side of the wreckage trail, near the side of the valley. The aircraft came to rest, inverted, halfway up the side of the valley, approximately 425 feet from the initial point of contact with the marsh surface. The aircraft was destroyed by impact forces.

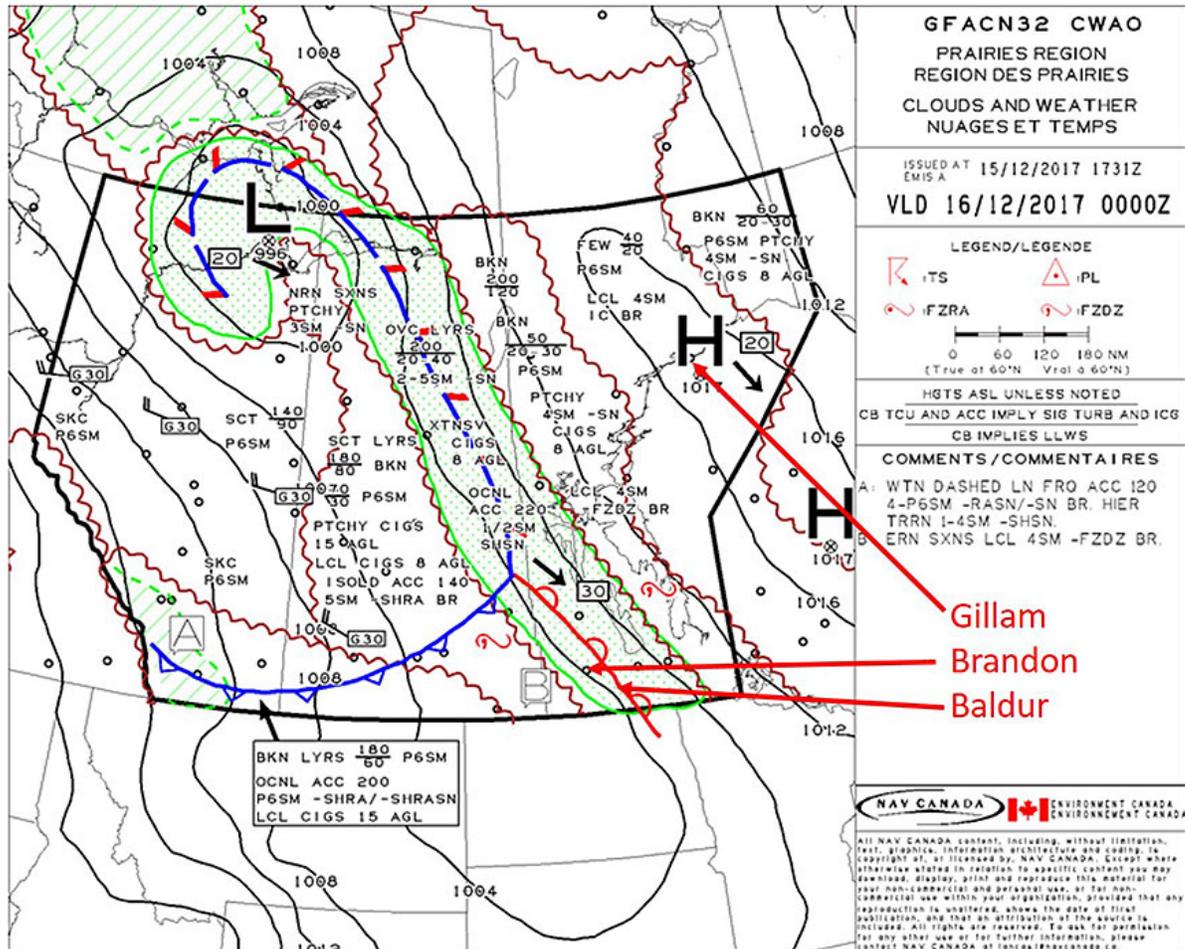
Figure 4. Graphical area forecast (Source: Environment and Climate Change Canada, with TSB annotations)

The weather at CYGX at the time of the aircraft's departure was reported as clear sky conditions, light winds, temperature of -26°C and an altimeter setting of 29.92 in. Hg. The forecast weather, available at the time of departure and based on the graphical area forecast, indicated that extensive ceilings of 800 AGL with visibility of 2 to 5 sm in light snow with occasional visibility of $\frac{1}{2}$ sm were expected for the Baldur area (Figure 4).
