AVIATION OCCURRENCE REPORT
SEPARATION IN FLIGHT - COWLING

CONTACT AIRWAYS LTD.
BEECH KING AIR 100 C-GNAA
EDMONTON, ALBERTA 50 NM N
26 SEPTEMBER 1995

REPORT NUMBER A95W0180

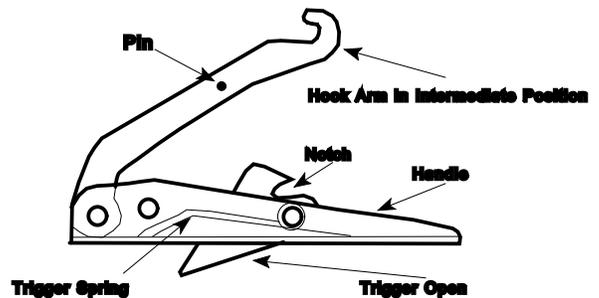
LATCH ENGAGED

Both the H296K854 latches and the H296K1135 latches are an overcentre toggle-type latch. The primary locking action is due to tensile loading and the toggle effect between the handle and the hook arm. The edges of the trigger are notched pawls that engage pins on the hook arm to act as a secondary locking device. The top of the trigger must be pushed to release the latch. The trigger is retained in the closed position by a spring. The trigger hinge is set toward the top of the trigger. A pressure differential between the inside and outside of the cowling will tend to open the trigger if the pressure is great enough to overcome the spring and friction resistance. Light tensile loading on the hook will permit the handle to open if the trigger releases.

The aircraft manufacturer reported that the plenum area of the cowling may reach a differential pressure of up to 1.1 psi at 200 knots IAS, due to the combination of ram air effect in the inlet and airflow over the nacelle. Post accident testing determined that the trigger on the forward latch would disengage with an internal air pressure of about one pound per square inch. Calculation determined that with the trigger disengaged, at least 300 pounds of hook tension would be required for the toggle mechanism to keep the handle shut. The rigging of the cowling and the tensile loading on the latches before the occurrence could not be determined.
