MARINE OCCURRENCE REPORT

M95W0187

COLLISION

BETWEEN THE FISHING VESSEL
"ROXANA GLEN"
AND THE TUG-BARGE UNIT
"ARCTIC TAGLU"/"LINK 100"
FRASER RIVER, BRITISH COLUMBIA
31 OCTOBER 1995

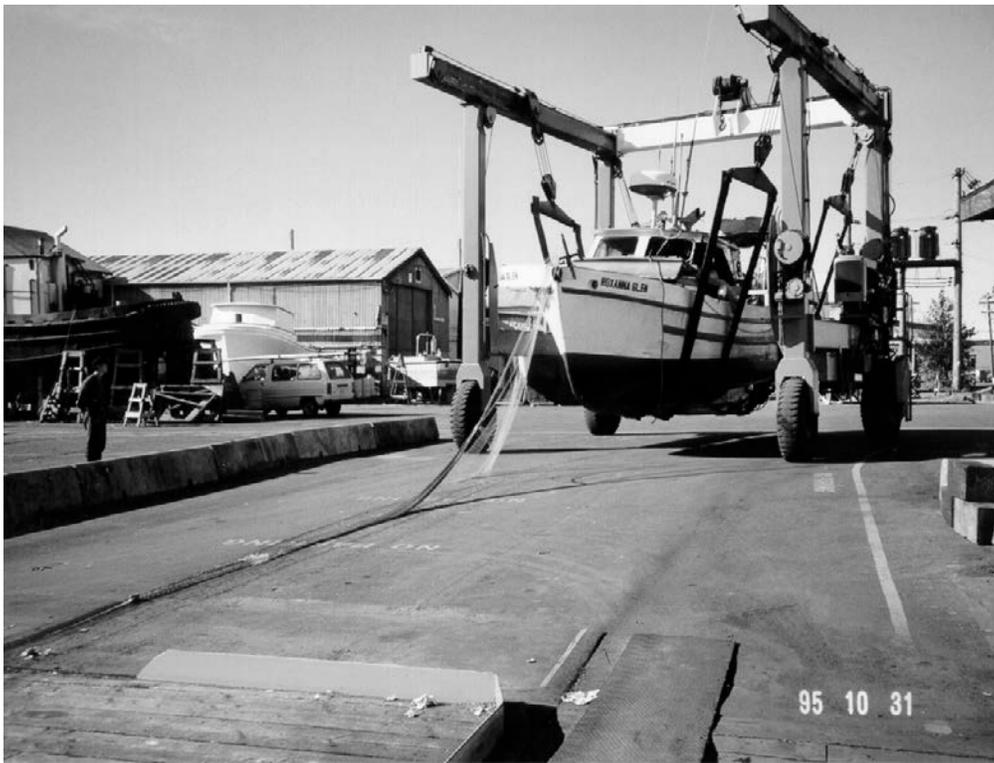
Appendix B - Photographs

The fishing vessel was extensively damaged. The starboard side was stove in, in way of the engine compartment. The deck and the hull on the starboard side were opened up over a length of approximately 1.5 m. The wheel-house was dismantled from the deck and pushed sideways. The vessel was declared a constructive total loss. Some fuel escaped; however, no significant pollution was reported.
