RAILWAY INVESTIGATION REPORT

R01E0009

DERAILMENT

CANADIAN PACIFIC RAILWAY

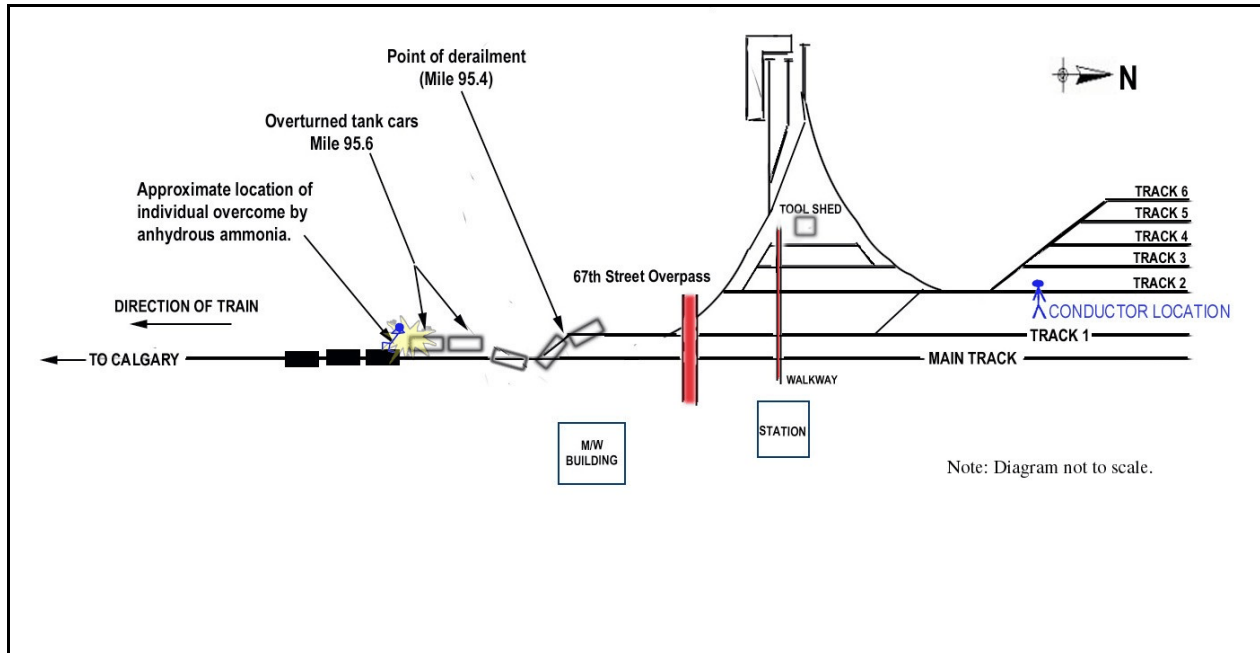
At approximately 2023 mountain standard time (MST)¹ on 02 February 2001, Canadian Pacific Railway (CPR) train CP 966-02 was being prepared for departure in the Red Deer yard. Part of the preparation involved the movement of 61 cars from Track 1 to set off one car to Track 5 and to pick up 12 cars from Track 2 to fill out the train. Figure 1 is a schematic diagram showing the south end of Red Deer yard.

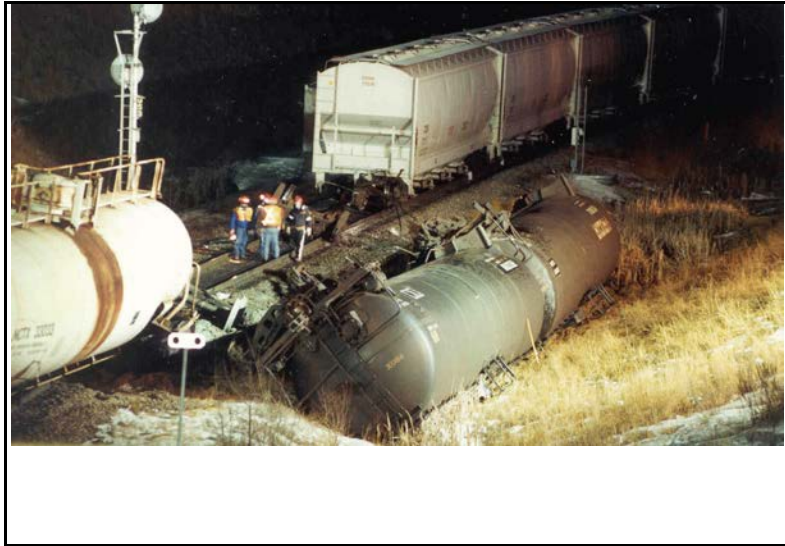
The locomotive engineer consulted the *2000 Emergency Response Guidebook* for the properties of and the proper response to anhydrous ammonia. Upon identifying the potential hazards, he disconnected the locomotive from the rail cars and departed from the scene. The conductor immediately went to the CPR yard office, located approximately 1500 feet from the overturned cars, to alert management and employees to the situation. Figure 2 shows the derailed and overturned ammonia tank cars.

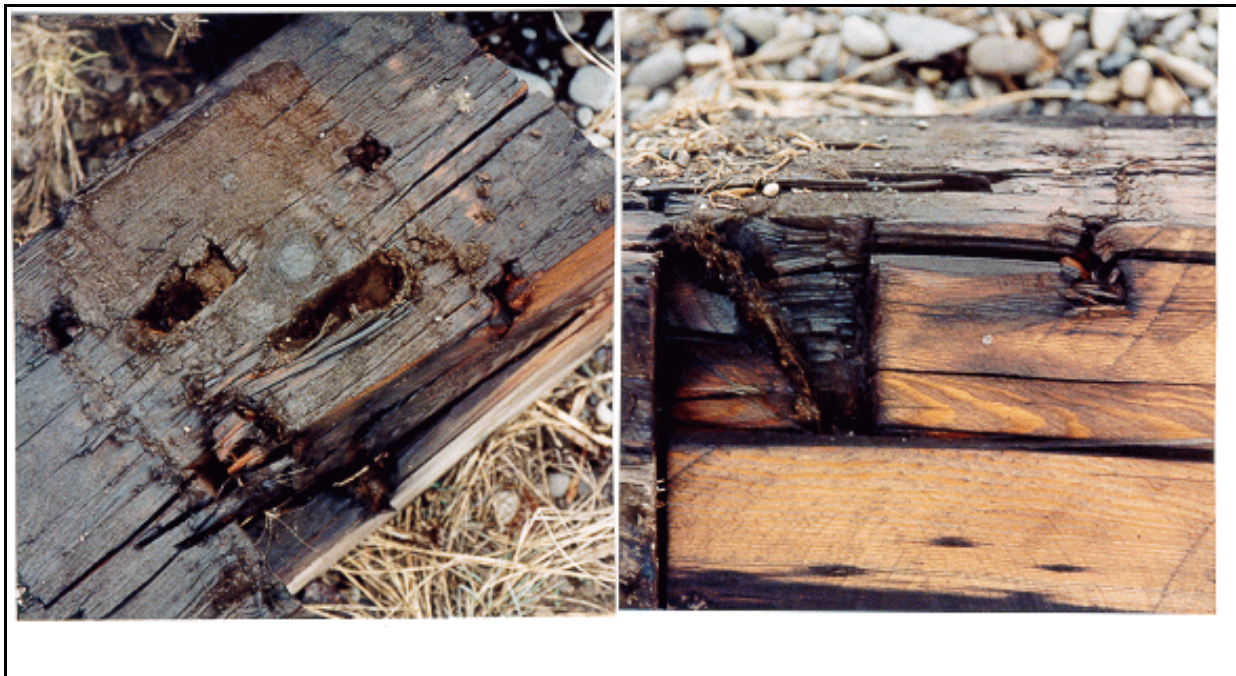
The yard track was built in 1991. The rail at this location was Algoma 115-pound, rolled in 1986 in various lengths. Lengths of rails were joined using splice bars with six track bolts. The subgrade, ballast, and track fasteners were in good condition. A post derailment inspection of the track ties revealed that there was approximately 2½ inches lateral movement in the spike hole and tie plate at the point of derailment. Deformations in the spike holes indicated that the ties were deteriorated and could not hold the proper gauge of

the rails. Figure 4 shows the lateral movement at the spike hole.

The bolt hole in the web of the rail had significant long term damage caused by the bolt rubbing against the hole, indicating that, at some point in time, the bolt had not been adequately tightened. As the nut of the bolt on the field side of the rail, and a spacer block on the gauge side, completely concealed the bolt hole, visual turnout inspections did not detect the damage. Monthly visual turnout inspections and detailed semi-annual turnout inspections, as outlined in CPR's Standard Practice Circulars - Track (SPC) No. 33 (effective 01 April 2000), may not be adequate to ensure the detection of damage to bolt holes in high risk sections of the track.

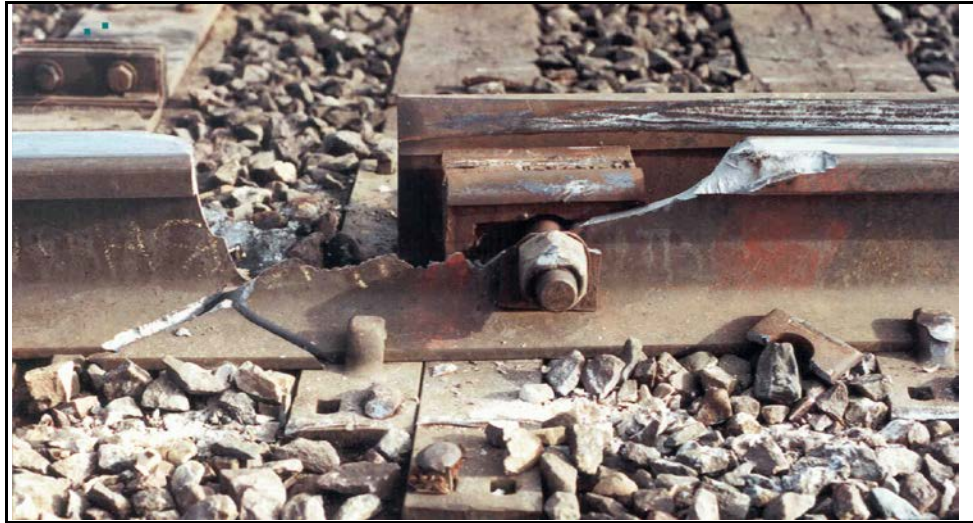
Wheel marks on the track cross-ties and fastenings indicated that the first derailed car of five loaded tank cars containing anhydrous ammonia had derailed at a location where 2¼ inch-wide gauge was measured. The derailed car traveled approximately 90 feet and then diverged from the rails at a frog. When the leading derailed wheel contacted the wing rail of the frog, the resultant lateral force on the opposite rails corresponding guard rail to running rail joint resulted in the complete fracture of the rail. The break was found to have originated from a damaged bolt hole where a guard rail was connected to the running rail (Figure 5).

The TSB Engineering Branch analyses revealed that the primary mode of failure was overstress originating from pre-cracks located on either side of a bolt hole. The pre-cracks were heavily oxidized, indicating long-term growth. One pre-crack measured 26 mm in length and had penetrated through the 17 mm thick web to the other side. The other pre-crack measured 18 mm in length and was 9 mm through the thickness of the web. Both pre-cracks coincided with significant prior damage to the bolt hole from rubbing by a loose bolt. The rubbing had resulted in deformation of the bore of the hole, and extrusion of the metal forming a lip on the outside surface.

The damage to the bolt holes caused two pre-cracks to form in the rail. Their location was such that they too would not have been detected during the monthly turnout inspections. Both pre-cracks were large enough to reduce the strength of the rail to such an extent that the lateral stresses caused by the derailed car hitting the frog were great enough to fracture the rail.

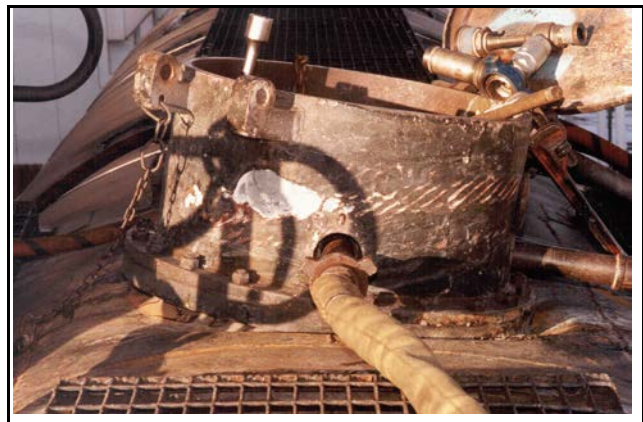
Three cars remained upright, but the two leading cars (PROX 88421 and PROX 37981) had rolled over falling into the ditch, with the manway nozzles of these cars striking the frozen ground. The entire contents of PROX 88421 were lost due to impact damage (Figure 6). No product was released from the other derailed cars.

TSB Engineering Branch Report LP009/2001 indicates that the manway nozzle of tank car PROX 88421 was subjected to a significant overstress during the derailment and falling over which led to a brittle fracture opening of some 5.125 square inches in the heat-affected zone of the weld between the manway nozzle and the shell of the tank (Figure 7). The car also sustained a shear fracture of the metal at the sill area which initiated from a small pre-crack located in the toe of the sill-to-pad weld on the outside of the sill. The ammonia was released into the atmosphere gradually, which prevented the formation of a large cloud of gas at the time of the occurrence. Liquid ammonia was still slowly leaking from the car 24 hours after the occurrence.

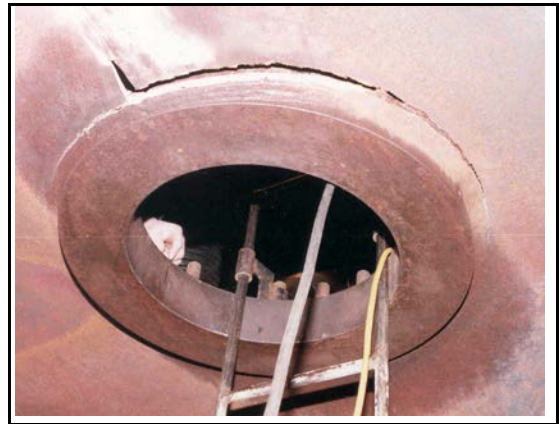
The report also revealed that there were three shallow pre-cracks, ranging from 11 mm to 45 mm in length, on the inner surface of the plate steel, which probably formed as a result of thermal stresses induced at the time of construction. There was no evidence of pre-impact growth and the surfaces of these cracks were covered with thick oxide layers (rust), indicating that they had been present and lain dormant for some time. A review of the running history and maintenance of this car (PROX 88421) proved uneventful as no significant repair history was indicated. The report also indicated that the structural failure was a brittle fracture due to the impact forces of the loaded tank car nozzle contracting the frozen earth. The kinetic analysis determined that the impact on the tank car nozzle was several times greater than that required to exceed the design strength of the car structure.

Tank car PROX 88421 had three shallow pre-cracks on the inner surface of the manway plate. It is likely that they were formed as a result of thermal stresses induced by the welding of the manway nozzle to the shell of the tank at the time of construction. Although cracks of this nature would not normally be expected to weaken the load-bearing ability of the plate, they do provide an imperfection in the surface metal and can act as points of stress concentration and provide origins for brittle failure. Therefore, while these pre-cracks may exist for many years without compromising the integrity of the plate under normal operating conditions, a brittle failure may occur when exposed to abnormally high stress levels at low ambient temperatures. The stresses caused by the impact to the manway nozzle exceeded the structural design capabilities of the tank, resulting in a brittle fracture and the gradual release of ammonia. The brittle fracture was confined to the heat-affected zone of the weld between the nozzle and the tank shell.
