RAILWAY INVESTIGATION REPORT
R05H0011

RUNAWAY AND MAIN-TRACK TRAIN COLLISION

OTTAWA CENTRAL RAILWAY
FREIGHT TRAIN NO. 441
MILE 34.69, ALEXANDRIA SUBDIVISION
MAXVILLE, ONTARIO
02 MAY 2005

Report Number R05H0011

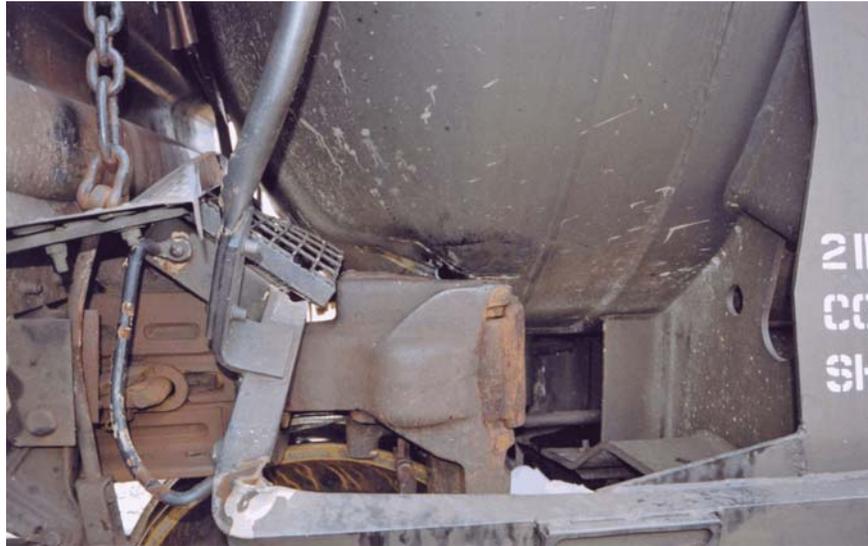
The two cars that collided, box car CN 557596 and tank car ADMX 29571, sustained impact damage. The B-end truck of the box car was displaced and pushed about 20 feet inward. The tank car head was dented and sustained a six-inch-long by two-inch-wide puncture (see Photo 1) caused by the box car's coupler.

Photo 1. Coupler of box car CN 557596 and punctured tank car ADMX 29571

Even though tank car ADMX 29571 was struck at low speed, the tank head did not withstand the impact of the box car's coupler and was punctured. This type of car has been involved in accidents previously investigated by the TSB, and its weaknesses have been acknowledged by the regulator and industry. The *Transportation of Dangerous Goods Regulations* have been modified to restrict the products these cars can carry, and design improvements that provide better valve roll-over protection have been implemented on newly constructed cars.

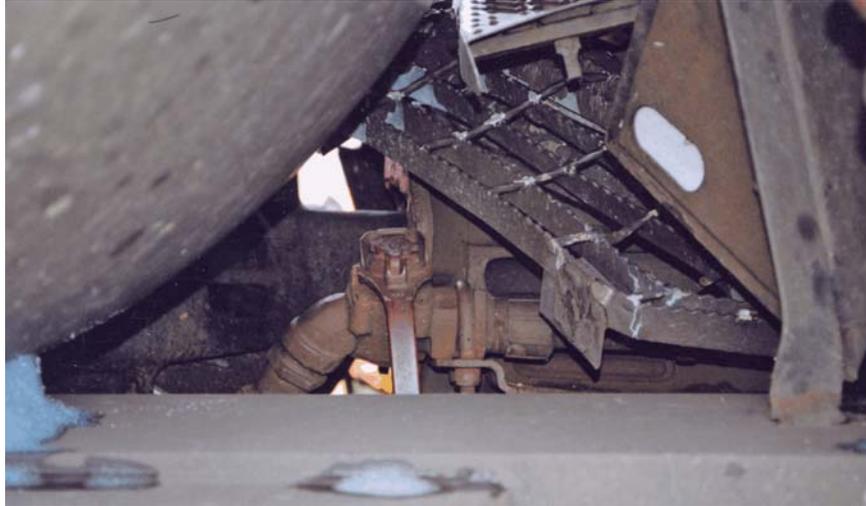
No pre-derailment damage of the equipment was observed and there was no track damage. It was noted that the angle cock on the B-end of the box car was fully closed (see Photo 2).

Photo 2. Closed angle cock of box car CN 557596

The train crew left a standing cut of 74 cars on a 0.5 per cent descending grade with the air bottled. These actions were not in compliance with either CN's System Special Instructions regarding CROR Rule 112 or the company GOIs. While bottling the air does not always lead to adverse consequences, the practice increases the risk of premature brake release that results in uncontrolled runaway cars.

1. The 74 cars, left unattended with the air bottled, rolled downgrade and collided with the reversing head-end movement, which resulted in the puncture of tank car ADMX 29571 and the release of 98 000 litres of denatured alcohol.
2. The angle cock was closed before the air brake pipe pressure had equalized and the brakes had fully applied at the tail end. This initiated a pressure wave within the train air brake line and resulted in the undesired release of air brakes.
3. Because train crews are unlikely to bottle the air when they know that they are being observed and the end-of-train (EOT) air brake line pressure is not being recorded, regulatory and company monitoring did not adequately deter train crews from bottling the air.

On 11 May 2005, Ottawa Central Railway (OCR) held a safety meeting that was attended by all employees. The events surrounding the accident were discussed to raise awareness about the risks associated with the practice of bottling the air.

For two months after the accident, OCR doubled the number of train crew observations, emphasizing the securing of unattended cars while performing en route switching. The number of safety audits performed was doubled for 2005.

OCR purchased a portable input and display unit (IDU) to install in a vehicle for transportation supervisors. The IDU will be used to remotely monitor the end-of-train air brake pipe pressure while transportation supervisors observe train crews perform en route switching.

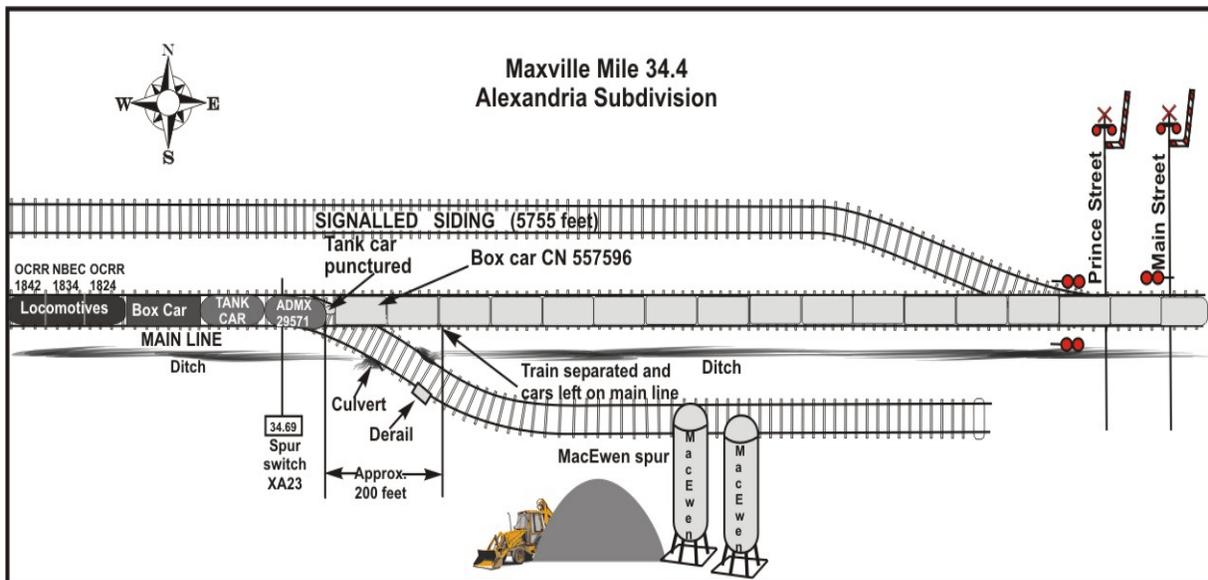
Figure 2. Accident site diagram

In the area of the accident, the track has an average descending grade of 0.5 per cent between Mile 33.0 and the MacEwen spur switch at Mile 34.69. West of the switch, the track levels off for about 280 feet. A signalled siding runs along the north side of the track from Mile 34.43 to Mile 35.73. There is an eight-foot-deep drainage ditch on the south side of the track (see Figure 2).
