RAILWAY INVESTIGATION REPORT R05T0030

PEDESTRIAN FATALITY

CANADIAN NATIONAL FREIGHT TRAIN Q-106-41-15 MILE 124.88, KINGSTON SUBDIVISION BROCKVILLE, ONTARIO 17 FEBRUARY 2005

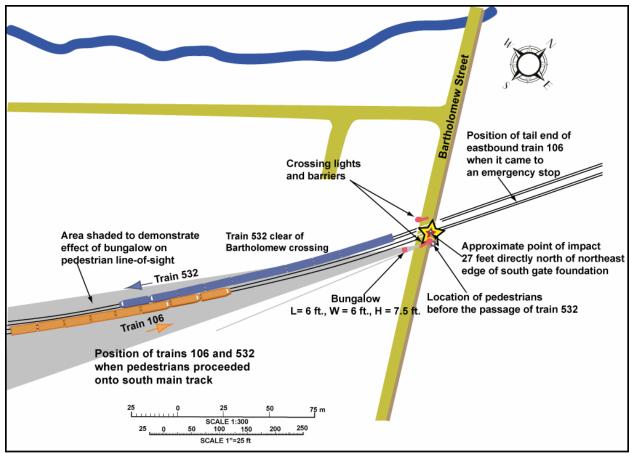
Canadian National (CN)¹ freight train Q-106-41-15 (train 106), travelling eastward on the south main track, approached the Bartholomew Street public crossing at 60 mph. At the same time, westward CN freight train 532, proceeding on the north main track at 40 mph, had nearly completed traversing the crossing. Two young girls were standing on the sidewalk clear of the south main track and on the east side of the street (see Figure 1). They were standing directly east of the crossing gate mechanism, facing north and looking east toward the approaching rear of train 532. As the rear car of train 532 cleared the crossing, the two pedestrians began walking north onto the south track where they were struck by train 106. At the time of the accident, the roadway gates were down and the flashing lights and bell were operating.

Figure 1. South main track and east side of the street

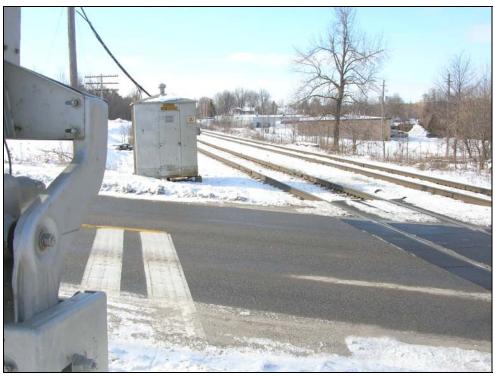
There are no signs, barriers or visual aids to indicate a safe distance for pedestrians to remain back from the track when trains are approaching. For some locations south of the signal apparatus, the sightlines are unrestricted. However, from the location where the two pedestrians were standing before proceeding onto the track, the view to the west was limited to less than 100 feet because of the location of the signal bungalow (seven feet from the rail) and the gate protection control mechanism (see Photo 1). This is the location where the majority of northbound pedestrians were observed to stand while waiting for a train movement to clear the crossing. The signal bungalow² is located 7.17 feet (2.18 m) south of the nearest rail.

Photo 1. View looking west from sidewalk in southeast quadrant of the Bartholomew Street level crossing

At the pedestrian crossing, there was no gate to restrict movement and no pedestrian-specific signals. Having seen the first train pass, with their westward view obstructed by the signal bungalow, and without the benefit of the second train's whistle or other second-train-specific warning, the remaining cues (the closed vehicle gates, the flashing lights and bell) were insufficient to warn the pedestrians that entering the crossing remained unsafe because of the second train.

Existing TC sightline regulations only pertain to vehicular traffic. There are currently no regulations governing pedestrian sightlines. At the Bartholomew crossing, the westward view of the south track in the vicinity where the two girls were observed to be standing is restricted. The girls were adjacent to the east side of the signal mechanism where other pedestrians were observed to stand. A signal bungalow further restricts a pedestrian's view of the west side of the south track.

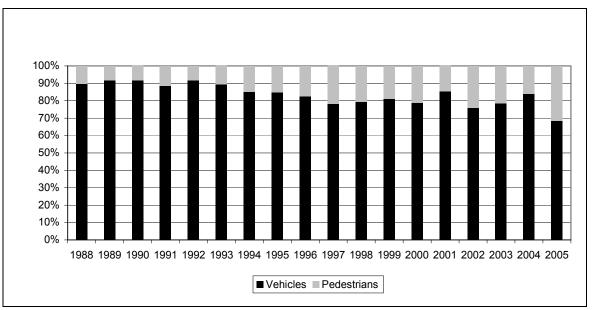
Figure 2. Crossing accident fatalities involving vehicles and pedestrians

Crossing accidents involving vehicles have shown a statistically significant decrease over the years (from 493 in 1988 to 249 in 2005), while those involving pedestrians have been fairly stable with an annual average of 14 since 1988.

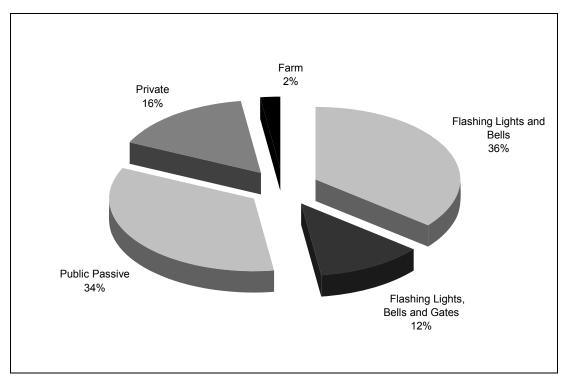
According to information reported to the TSB in the last 10 years, 48 per cent of crossing accidents involving vehicles occurred at automated crossings, 34 per cent at public passive crossings, 16 per cent at private crossings and 2 per cent at farm crossings. For the same period, 90 per cent of accidents involving pedestrians occurred at automated crossings (61 per cent at gated crossings and 29 per cent at crossings with flashing lights and bell (see Figure 3 and Figure 4)). Most gated crossings are equipped with gates that, when in the down position, extend across only the approaching lane of vehicular traffic (half barriers). The gates do not extend across the pedestrian approach.

Figure 3. Crossing accidents involving vehicles by type of crossing, 1996-2005

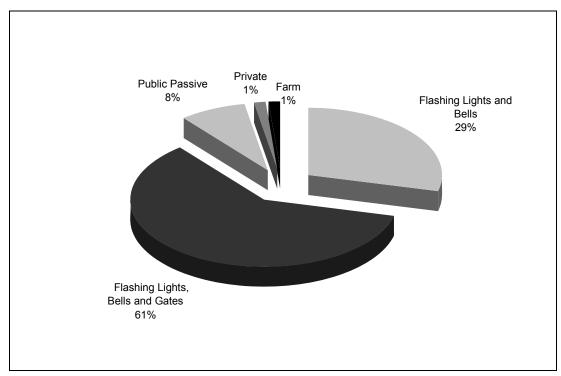
Figure 4. Crossing accidents involving pedestrians by type of crossing, 1996-2005
