RAIL TRANSPORTATION SAFETY INVESTIGATION REPORT R18Q0046

UNCONTROLLED MOVEMENT AND DERAILMENT OF ROLLING STOCK ON NON-MAIN TRACK

Quebec North Shore and Labrador Railway
Sept-Îles Yard
Sept-Îles, Quebec
01 May 2018

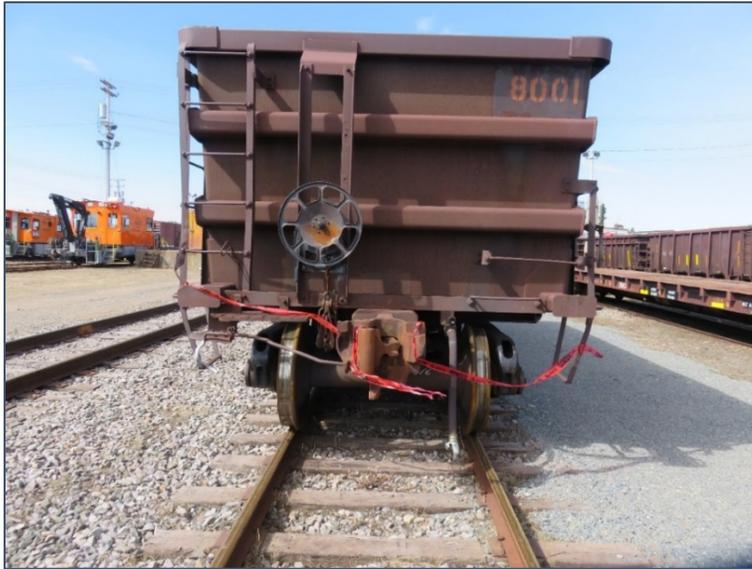
Figure 2. Ore car IOCC 8001 (Source: TSB)

At about 1423, the movement was backing up southward on track AT-03, at about 5 mph, on a descending grade. At 1425, in compliance with the regulatory provisions in effect,⁴ the ground operator asked the locomotive operator to stop the movement before the private grade crossing⁵ located about 1600 feet to the north of the shop. The empty ore car (IOCC 8001, shown in Figure 2), in 4th position from the head end of the movement, then uncoupled without the crew's knowledge, and the cut of 17 cars ran uncontrolled in a southward direction.

In this occurrence, when the movement was coupled with ore car IOCC 8001, it is likely that the coupler lock dropped only partially into position due to a lack of clearance caused by accumulated corrosion. It is likely that this corrosion had built up during the period of time when the car was not in use, and was not detected. A coupler assembly is considered an “on condition” item, so the Association of American Railroads (AAR) does not specifically require it to be inspected on a scheduled basis for conditions such as component wear, cracks, deformation, or missing parts. If coupler components are not required to be inspected on a scheduled basis, component wear and other defects may go undetected, increasing the risk that the coupler will not perform as intended.

4. When the movement was coupled with ore car IOCC 8001, it is likely that the coupler lock dropped only partially into position due to a lack of clearance caused by accumulated corrosion.

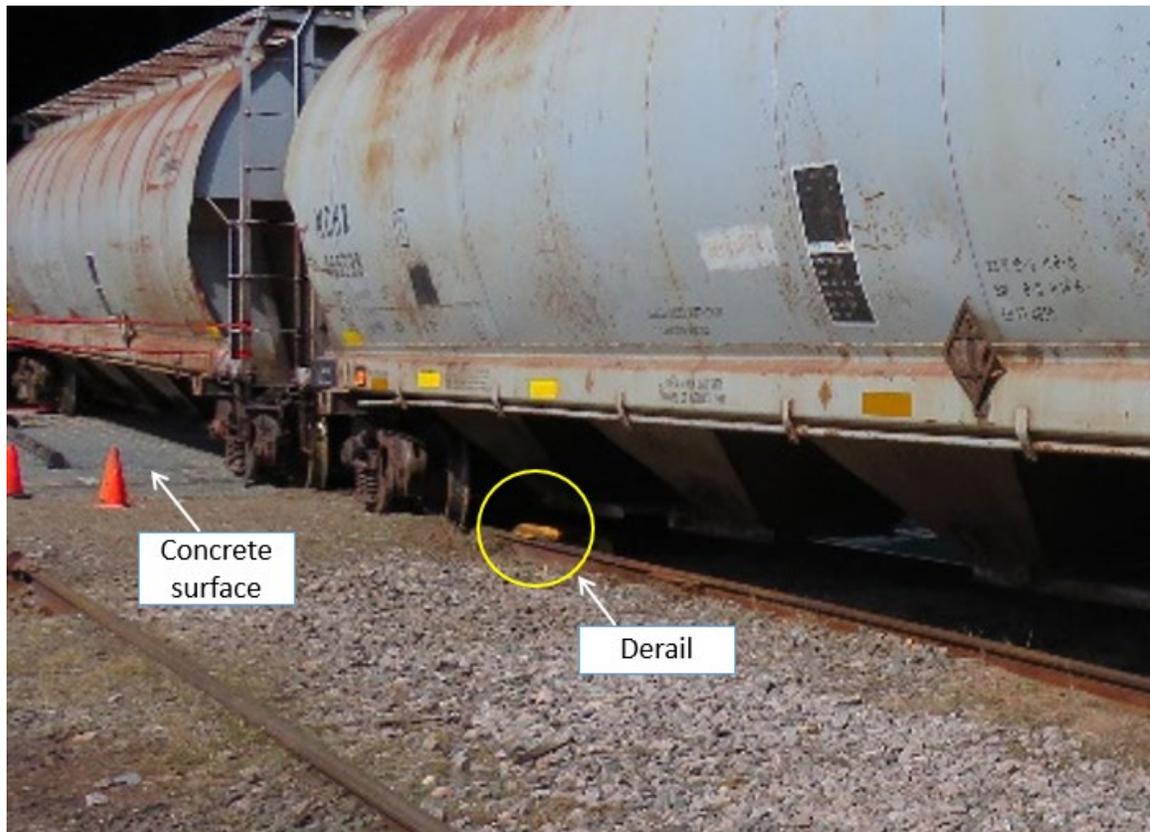
Figure 3. Concrete surface and position of derail (Source: TSB)

The cut of cars, with flat car QNSL 1862 leading, passed over the grade crossing, veered onto track 4 at switch AT-31, and headed toward the shop. The first 4 cars left the track on a sliding derail⁶ installed about 60 feet north of the shop. As required, the sliding derail was locked. The derailed cars proceeded over approximately 20 feet of ballast, remained upright and did not stop. They continued to roll and climbed onto a concrete surface leading to the shop door (Figure 3).

In this occurrence, a sliding derail was installed approximately 60 feet away from the shop on the track leading to the door of bay No. 4, in compliance with industry best practices. However, due to the presence of a concrete surface surrounding the shop, there was only approximately 20 feet of ballast available to trap and stop the derailed cars. In addition, the ballast was contaminated with sand. Therefore, the length and condition of the ballast was insufficient to dissipate the kinetic energy of the derailed cars.

Although the leading cars were derailed by the sliding derail, the cars remained upright and continued to roll onto the concrete surface just beyond the derail, allowing them to enter the shop. If a derail is installed at a location where the length and condition of the ballast is not sufficient to dissipate the energy of the rolling stock, the derail may not function as intended, increasing the risk of an accident or injury.

2. The first 4 cars left the tracks when going over a sliding derail, remaining upright. The derailed cars rolled over approximately 20 feet of ballast and then climbed on an adjacent concrete surface about 40 feet long leading to the repair shop.

3. The length and condition of the ballast was not sufficient to trap and stop the derailed cars effectively before they reached the adjacent concrete surface.

- Issued Circular No. 18-508 entitled Rolling Stock Switching Operation with Air, which stated that all crews must ensure that rolling stock is charged with air and has sufficient operational brakes (Appendix B).
- Eliminated the separate areas of Sept-Îles Yard so as to standardize operating rules in the yard and foster better overall understanding.
- Implemented new lock-out procedures for the protection of employees.
- Completed an evaluation of all derails and their placement on the tracks leading to the repair shops.
- Initiated a project for the replacement of sliding derails with switch derails.

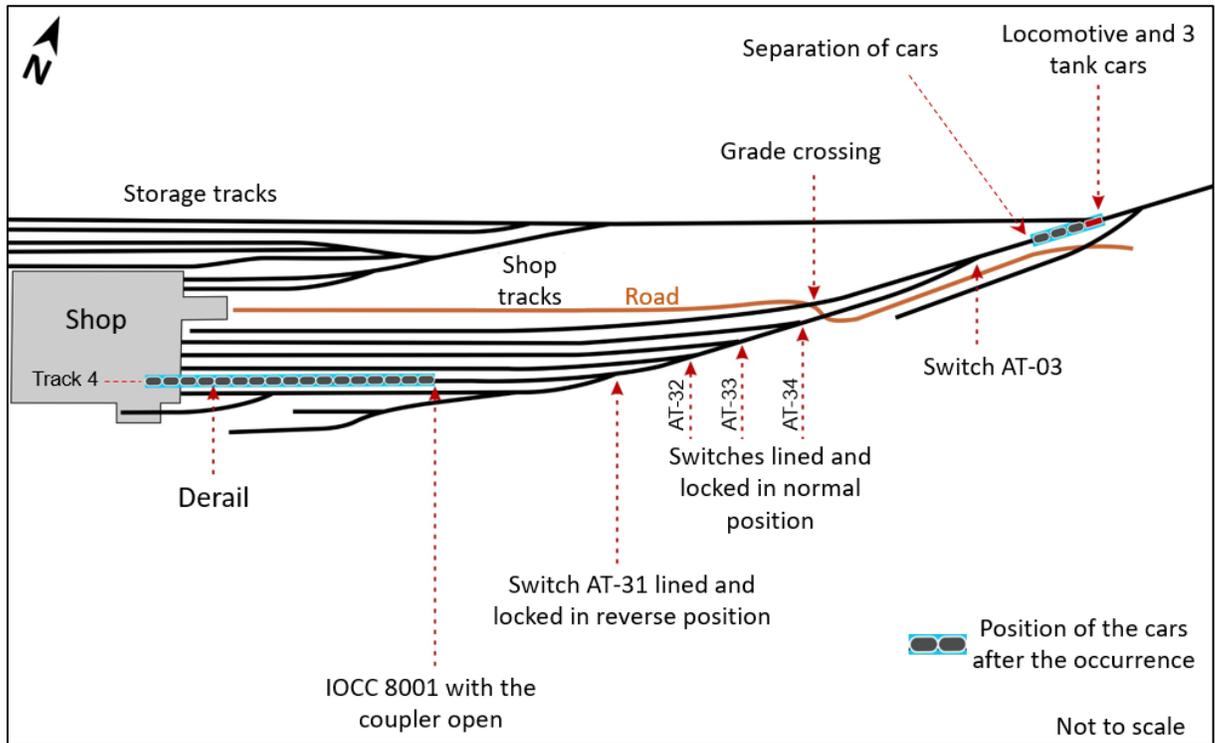
Figure 4. Position of the cars in Sept-Îles Yard after the occurrence (Source: TSB)

At 1427, lead car QNSL 1862 smashed through the door of bay No. 4, and the first 3 cars entered the shop (Figure 4).

The lead car rolled beyond a repair pit underneath track 4, struck parked track unit 46Q0802 (causing this unit to derail), and then came to a stop. The cut of cars travelled a total of approximately 1700 feet after they became uncoupled from the movement.

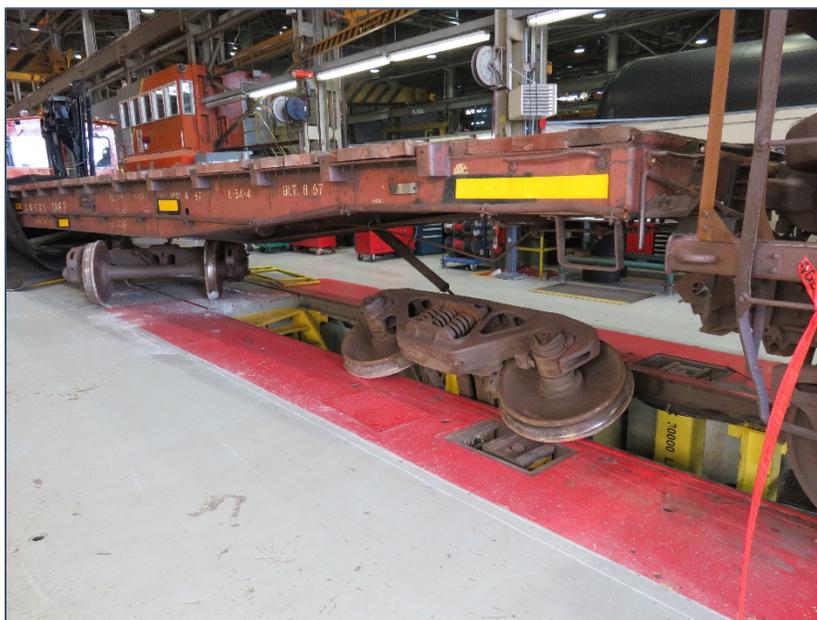
Figure 5. Trailing truck of flat car QNSL 1862 in the repair pit (Source: TSB)

The 17 uncontrolled cars were coupled to each other and came to rest on track 4. The lead car (QNSL 1862) had left the rails when it went over the derail. It had rolled over a short section of ballast that was contaminated with sand and onto a concrete surface. Its trucks

had separated from the platform and the trailing truck had fallen into the repair pit (Figure 5).

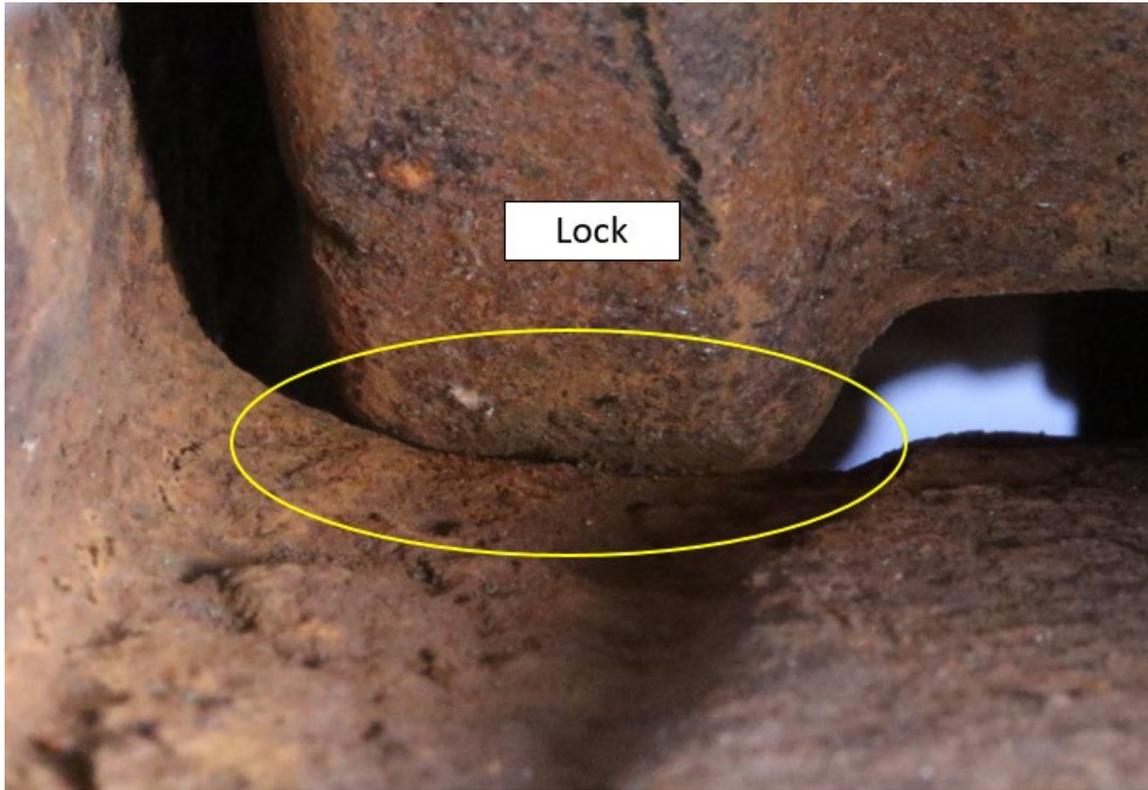
Figure 7. Interference between the lower corner of the lock and the back of the locking hole (Source: TSB)

During laboratory testing with all the original parts, it was observed that the lower corner of the lock did not drop into the locked position when the knuckle was closed slowly. The lock caught on the back of the locking hole because of accumulated corrosion (Figure 7). This interference prevented the lock from working properly.

The pull test that followed the coupling of the movement to ore car IOCC 8001 did not detect that the coupler was not locked. The interference between the lock and the knuckle tail, which was due to the presence of corrosion, was sufficient to prevent the knuckle from opening during the pull test.

5. The pull test that followed the coupling of the movement to ore car IOCC 8001 did not detect that the coupler was not locked.
6. The interference between the lock and the knuckle tail, which was due to the presence of corrosion, was sufficient to prevent the knuckle from opening during the pull test.
