AVIATION INVESTIGATION REPORT

A08A0106

LOSS OF CONTROL — STALL / SPIN

KITFOX IV C-GCSU

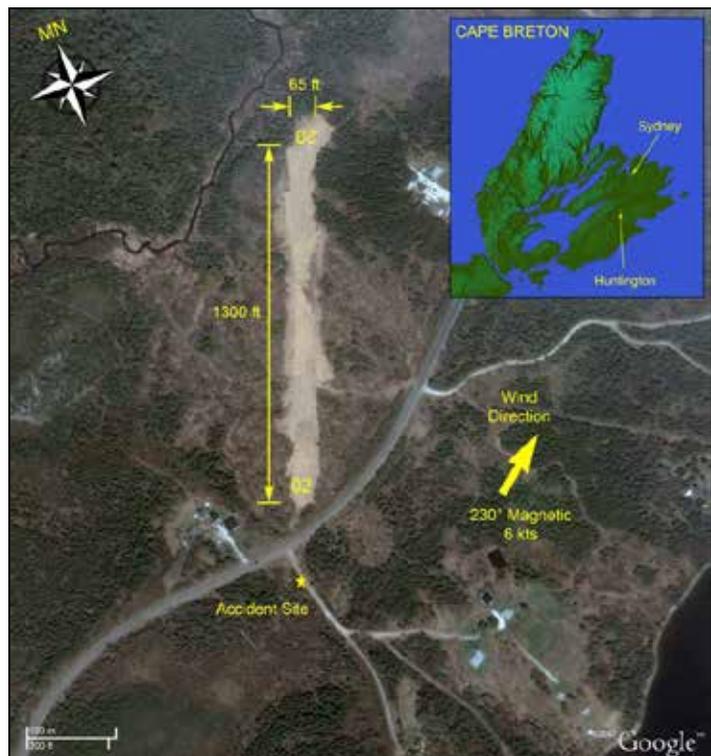
On the day of the flight, the pilot intended to conduct some practice in the local area. The sky was clear and the wind direction was approximately 230 degrees magnetic at less than 10 knots. The dirt airstrip runway orientation is 200 degrees/020 degrees magnetic and it is approximately 1300 feet long and 65 feet wide (See Photo 1). The pilot conducted a take-off from Runway 20 and then flew in a south-southwest direction. The time of departure was estimated as approximately 1115¹. A local resident heard the aircraft fly over and heard the sound of impact shortly after. Once the aircraft was located and the pilot extracted from the wreckage, the 911 emergency service was called at 1139 Atlantic daylight time. The local volunteer fire department, local police, and an ambulance attended the scene. The pilot was stabilized and transported to the local hospital, eventually being airlifted to a hospital in Halifax due to the extent and severity of his injuries. Those injuries restricted his ability to recall any significant details of the accident flight.

Photo 1. Aerodrome and accident site location
