**AVIATION INVESTIGATION REPORT
A14O0164**

RISK OF COLLISION

JAZZ AVIATION LP DHC-8-102 C-GJMI

**SAULT COLLEGE OF APPLIED ARTS AND TECHNOLOGY ZLIN
Z242L C-FANU**

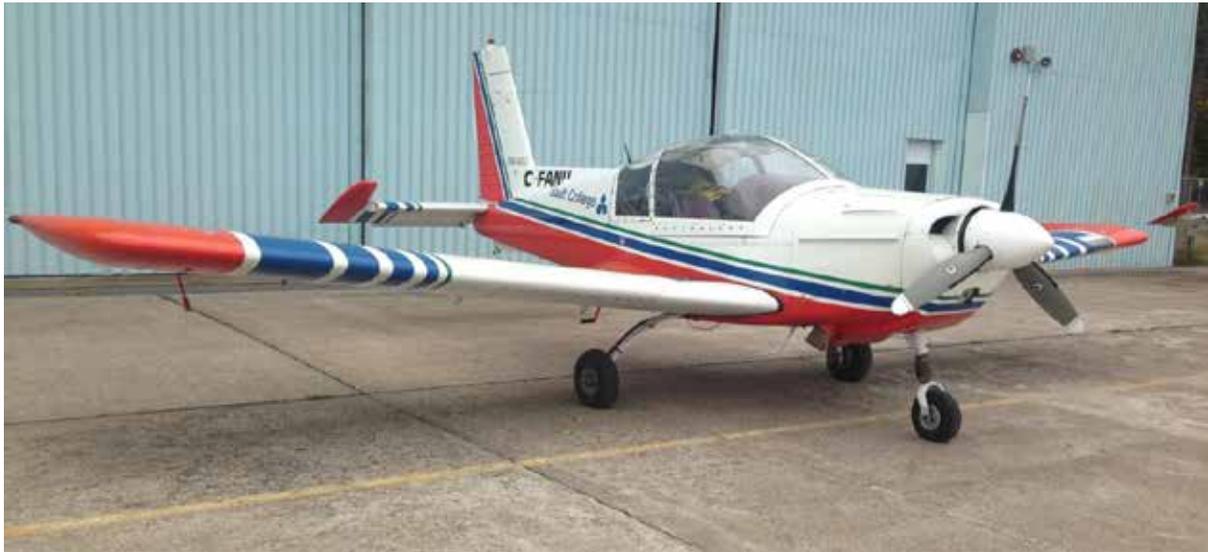
Photo 1. ZLIN 242L C-FANU (Source: Sault College of Applied Arts and Technology)

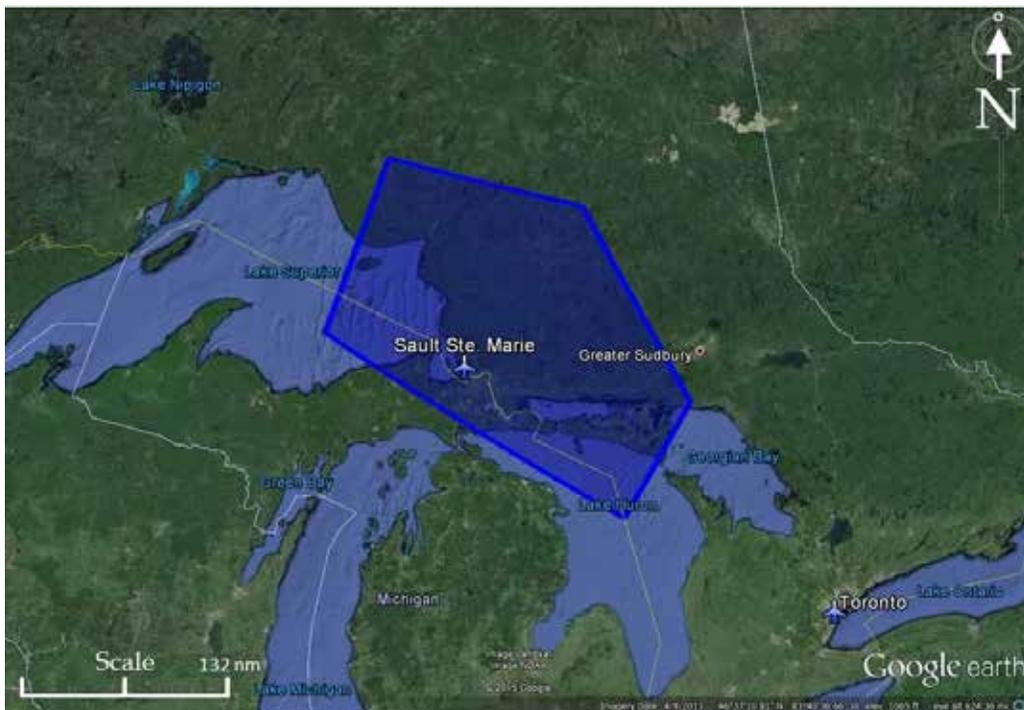
This responsibility is divided into several specialties, and these are further subdivided into sectors. The sector responsible for the occurrence airspace is labelled Sault Low. This sector forms part of the North Specialty. The sector (Figure 2) is relatively large and encompasses an area of approximately 150 nm by 235 nm.

Figure 2. Approximate boundaries of the Sault Low sector (Source: Google Earth, with TSB annotations)

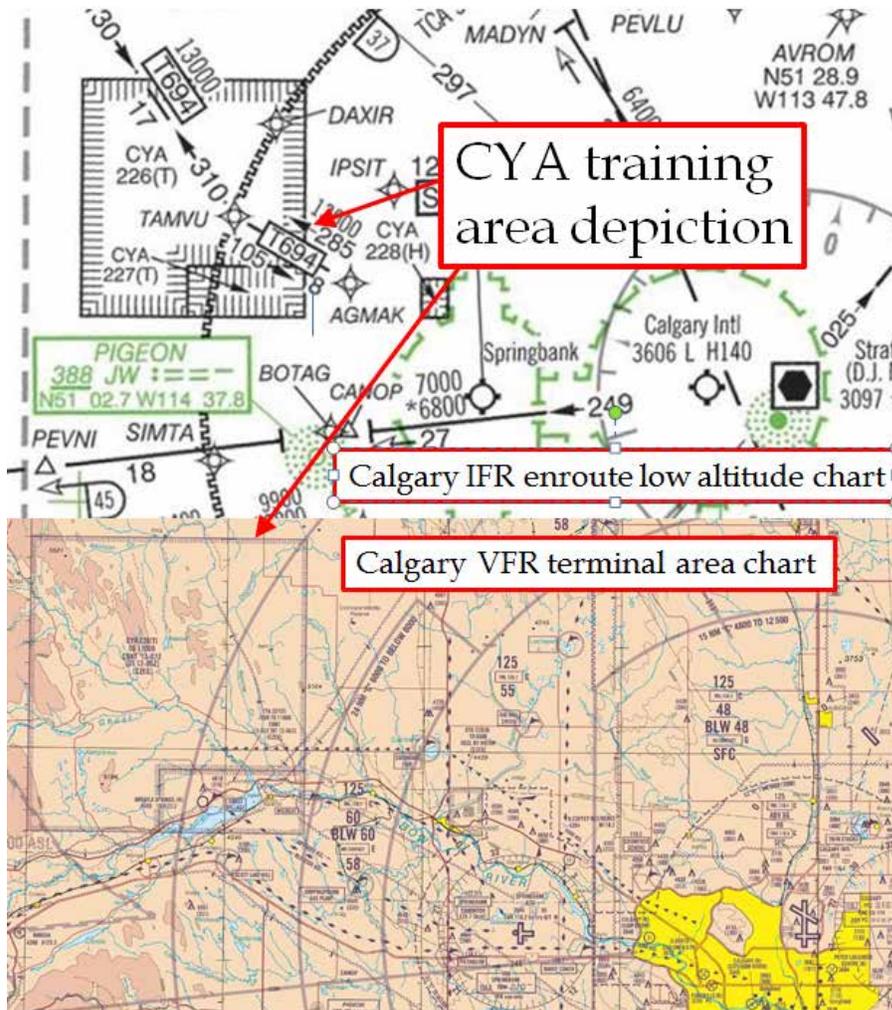
Figure 7. Depiction of training areas on VFR and instrument flight rules (IFR) charts
(Source: NAV CANADA, with TSB annotations)
