MARINE INVESTIGATION REPORT

M99W0133

COLLISION

BETWEEN THE PLEASURE CRAFT *SUNBOY* AND THE  
TUG *JOSE NARVAEZ* TOWING THE

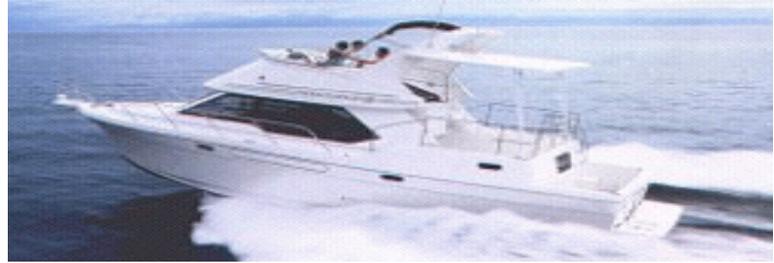
#### *Sunboy*

The *Sunboy* is a Bayliner pleasure craft (1998 model 4087), constructed of glass-reinforced plastic. It has three decks. The lowest of these consists of sleeping accommodation forward of an engine compartment; above it is a weather deck superstructure fitted with a control station on the starboard side of the salon. Atop the superstructure is an exterior command bridge deck with built-in seating and a second control station. Manufacturer's information states that the vessel has a cruising speed of approximately 15 knots.

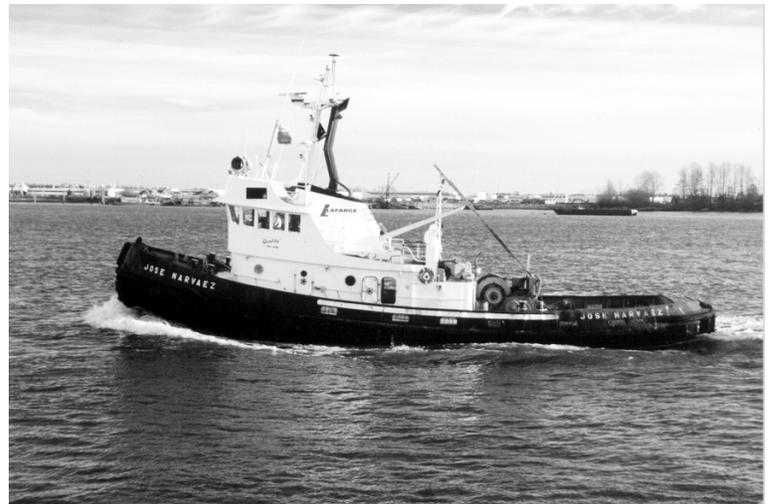
#### *Jose Narvaez*

The *Jose Narvaez* is a single screw, steel-hulled tug. The weather deck is fitted with an enclosed deck-house forward of a main working deck. Atop the deckhouse is the boat deck with an enclosed wheelhouse with centreline helm, and windows providing an unrestricted view ahead but a restricted view astern. At the exterior, after end of the boat deck is a second set of clutch controls, an emergency towing winch release and a 150,000 candela searchlight. The vessel's service speed is approximately 7.5 knots. The vessel is equipped with 790 m of 45 mm diameter steel wire towline on a single drum towing winch. The winch has one local and two remote emergency release stations.

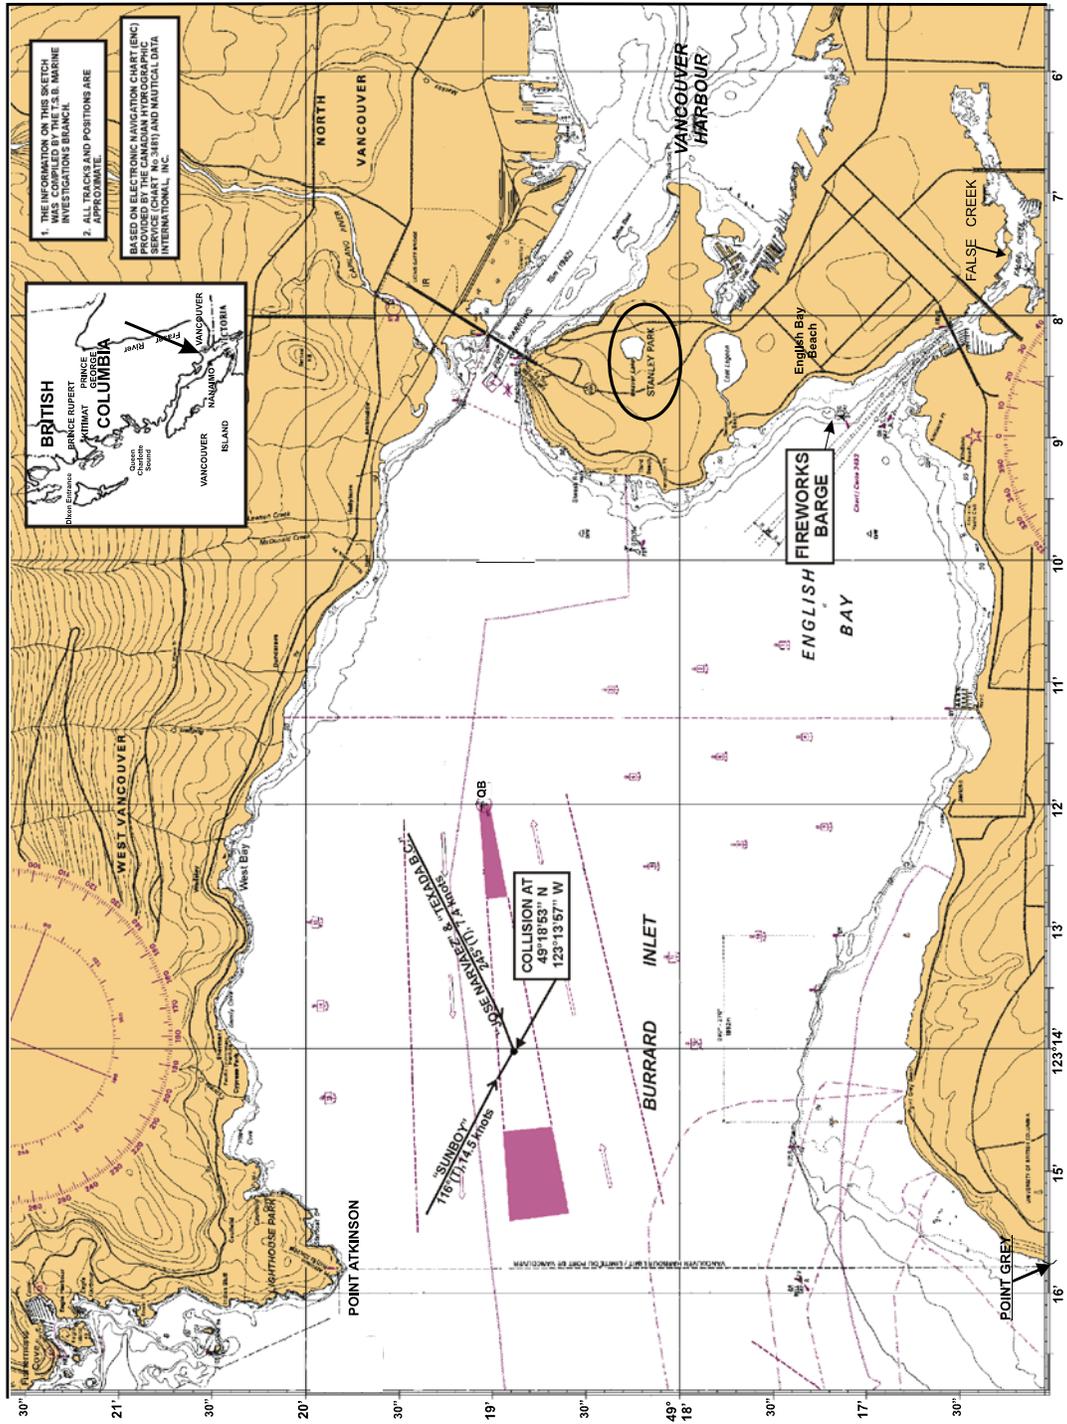
# Appendix A - Sketch of the Occurrence Area

A traffic separation scheme is a routing measure that provides for the separation of opposing streams of traffic, through the establishment of traffic lanes. The scheme in the Strait of Georgia begins north of Boundary Pass and leads north along the east side of the strait into Burrard Inlet. The scheme is recommended for use by all ships, particularly those 20 m or more in overall length. At the time of the collision, the tug and barge had left the outbound traffic lane before its natural terminus and entered the traffic separation zone on a southwesterly heading toward buoy “QA”. The pleasure craft was in the process of crossing the same traffic separation zone in a southeasterly direction (see Appendix A).
