MARINE INVESTIGATION REPORT
M07L0158

STRIKING

PASSENGER VESSEL *NORDIK EXPRESS*
ENTRÉE ISLAND, HARRINGTON HARBOUR, QUEBEC
16 AUGUST 2007

Report Number M07L0158

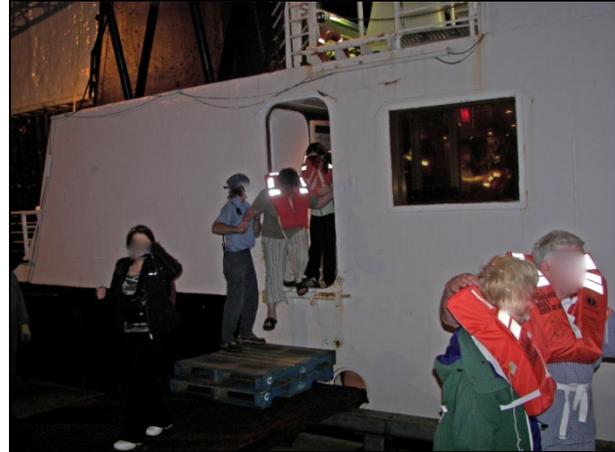
Photo 3. Passengers disembarking at Harrington Harbour

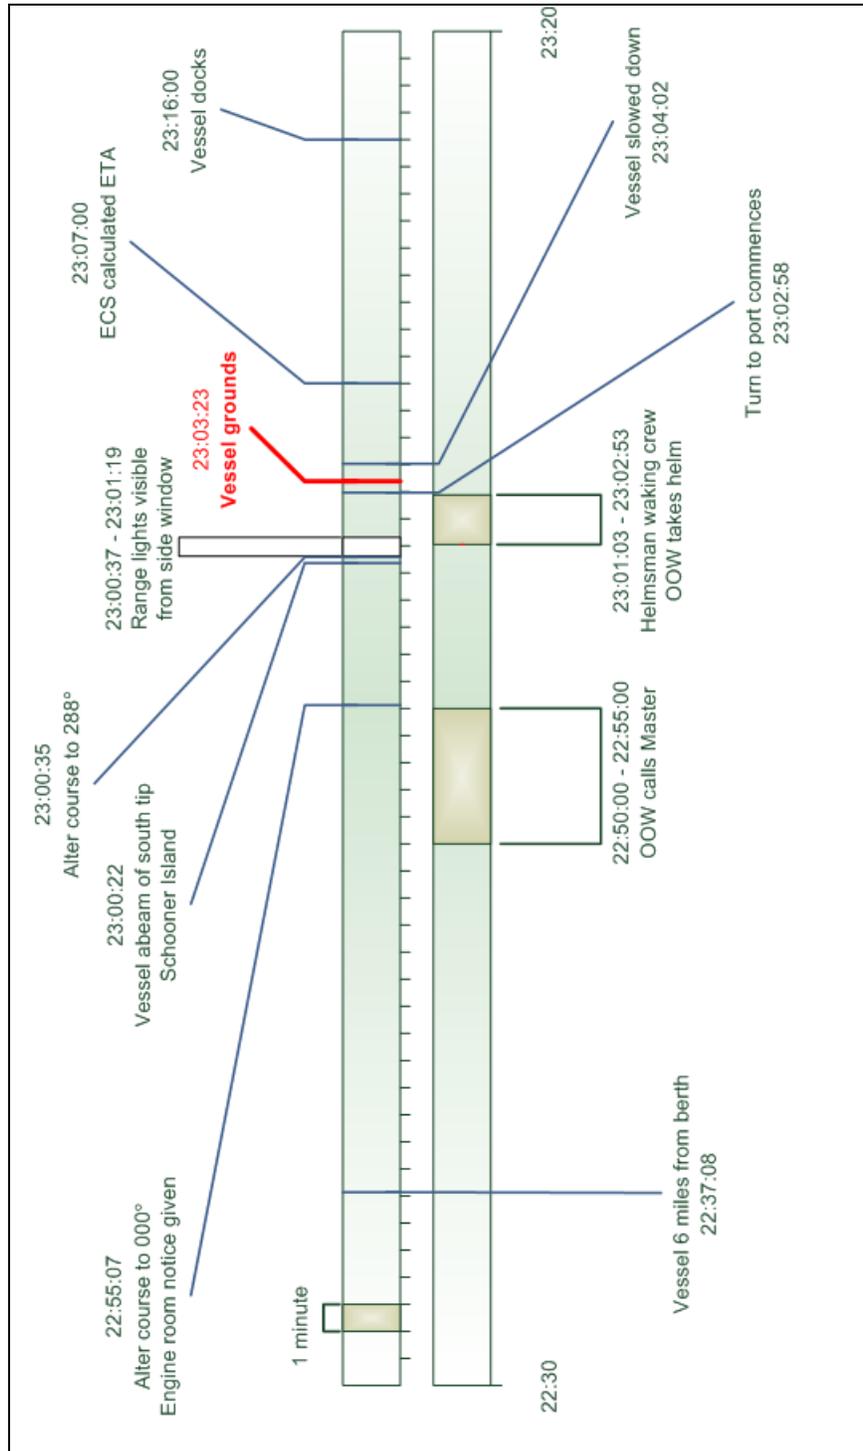
Appendix E – Occurrence Timeline

Within minutes of the striking and as a result of damage below the waterline, the vessel developed a list of approximately 20° to starboard; however, by the time it reached its berth, this was reportedly less than 10°. For a graphic depiction of the occurrence timeline, refer to Appendix E.
