**MARINE INVESTIGATION REPORT
M14A0348**

COLLISION

**PILOT BOAT *CAPTAIN A.G. SOPPITT* AND
PASSENGER VESSEL *BAYLINER*
MAIN CHANNEL INTO THE PORT OF SAINT JOHN
SAINT JOHN, NEW BRUNSWICK
01 AUGUST 2014**

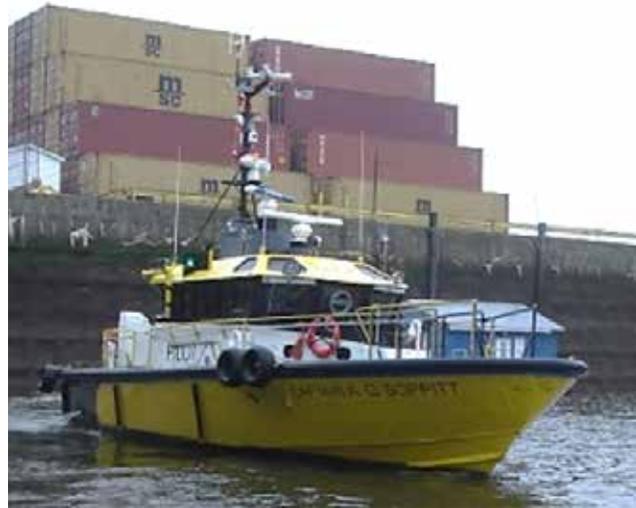
Photo 1. *Captain A.G. Soppitt*

The *Captain A.G. Soppitt* is a purpose-built aluminium vessel designed and equipped for transporting marine pilots (Photo 1, Appendix A). The vessel has a hard chine,² deep-vee planing hull and a maximum speed of 24 knots. Propulsion is provided by two 5-bladed propellers measuring 89 cm in diameter, each driven by a diesel engine through a custom gear-driven marine transmission.³ The vessel has 2 spade-type rudders. A series of 9 large windows provides visibility on the bridge.

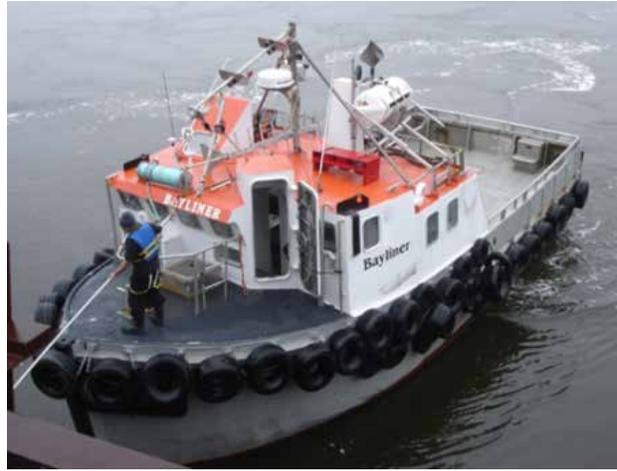
Photo 2. *Bayliner*

The *Bayliner* is a small aluminium vessel of closed construction (Photo 2). The deckhouse is located forward of amidships and contains the conning station, the galley, and the entrance to the crew accommodation below deck (Appendix C). The navigation and communication equipment is located near the seated conning station on the starboard side of the vessel and includes a radar, a depth sounder, an autopilot, a magnetic compass, a fog horn, 2 VHF DSC radiotelephones, 2 global positioning system (GPS) receivers, and an ECS. The ECS is loaded

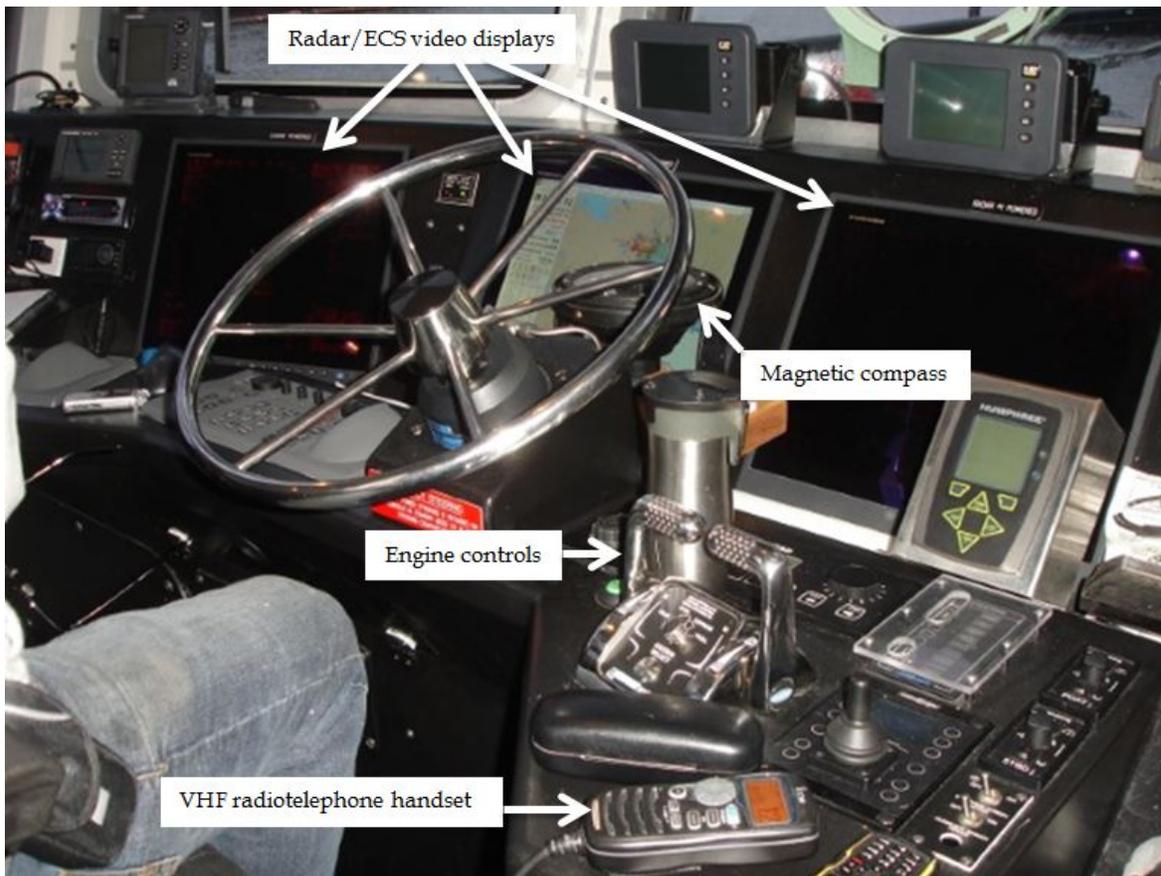
Appendix B – Captain A.G. Soppitt conning position

The integrated bridge includes a set of three 20-inch video screens that can display navigational information from 2 marine radars and 2 electronic charting systems (ECS) (Appendix B). The bridge is also equipped with 2 very high frequency (VHF) radiotelephones with digital selective calling (DSC), a magnetic compass, a satellite compass, an autopilot, a depth sounder, a weather station, and an automatic identification system (AIS).⁴ The vessel is also fitted with a manually operated fog horn, a thermal camera, and an automatic horn, but neither the thermal camera nor the automatic horn was operational at the time of the occurrence.

At 2045, the *Captain A.G. Soppitt*’s main ECS froze in position 45.198° N, 065.992° W with a vessel heading of 000°. The time displayed on the ECS also jumped back by 1 minute and 4 seconds.¹² The bridge team was not using this ECS and was unaware that it had failed.

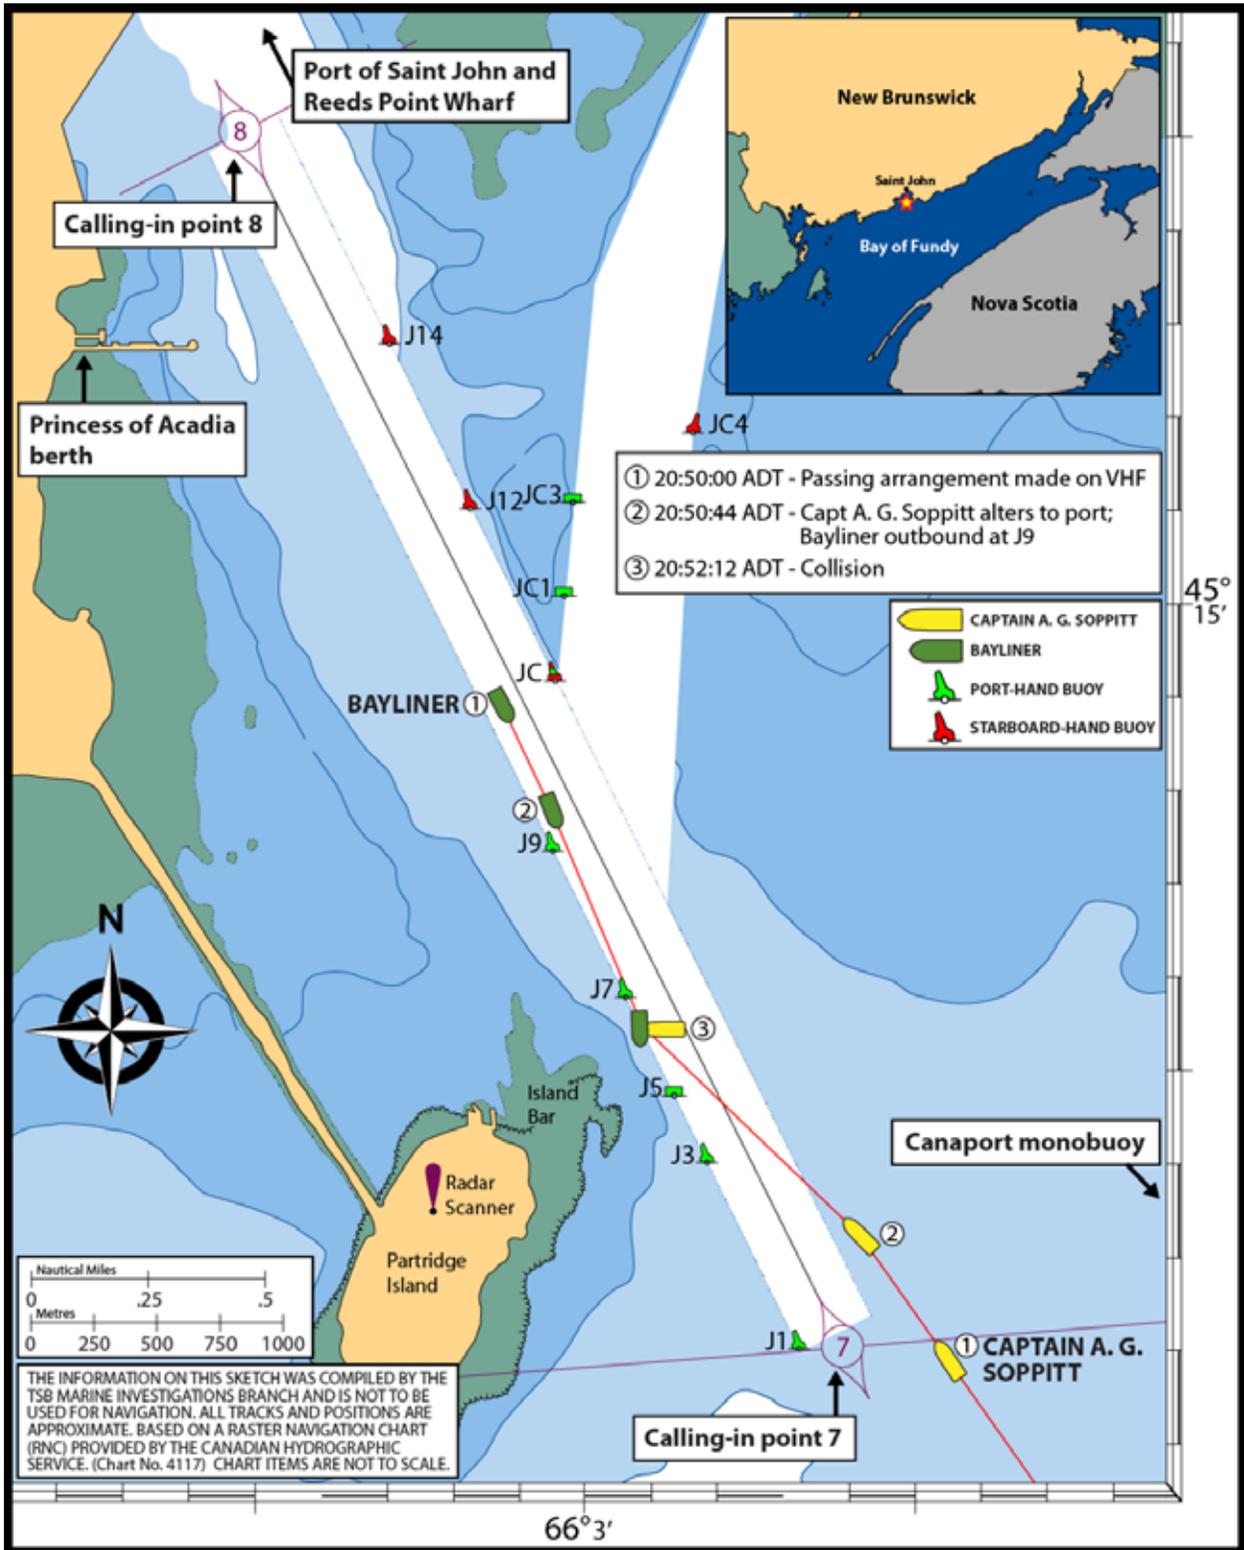
Appendix D – Main channel leading into the Port of Saint John

The main channel leading into the Port of Saint John is 1.45 nautical miles (nm) in length and 0.08 nm in width (Appendix D). The south end of the main channel begins at calling-in point (CIP) 7 and joins the harbour entrance at CIP 8. The channel is delimited by 3 red starboard-hand buoys (J12, J14, J16) and 5 green port-hand buoys (J1, J3, J5, J7, and J9).⁷ A bifurcation junction (JC) buoy indicates the secondary channel to Courtney Bay. The inbound course is 333.5° true (T) and the outbound course is 153.5°T.
