RAILWAY INVESTIGATION REPORT
R06V0183

RUNAWAY AND DERAILMENT
WHITE PASS AND YUKON ROUTE
WORK TRAIN 114
MILE 36.5, CANADIAN SUBDIVISION
LOG CABIN, BRITISH COLUMBIA
03 SEPTEMBER 2006

Report Number R06V0183

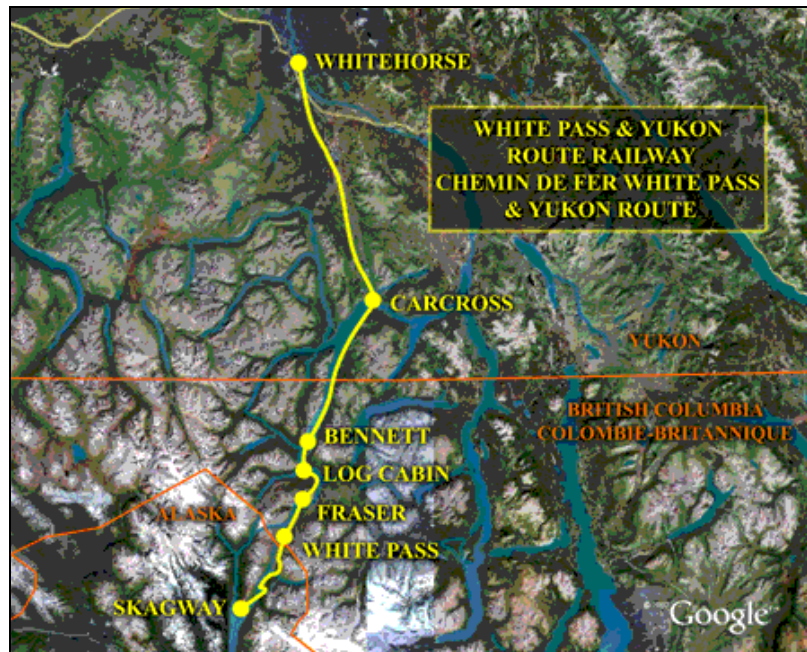
Figure 1. Location diagram

On 03 September 2006, at approximately 0700 Pacific daylight time,¹ the crew of White Pass and Yukon Route (WP&YR)² work train 114 (the train) reported for duty at Skagway, Alaska (see Figure 1), and proceeded by highway to Log Cabin, British Columbia, Mile 33.0 on the Canadian Subdivision. Eight ballast cars were stationed at Log Cabin waiting to be loaded and taken to Bennett, British Columbia, Mile 40.6 on the Canadian Subdivision. The dispatcher,³ based in Skagway, was not apprised of their operation.
