## **RAILWAY INVESTIGATION REPORT**

**R08M0063**

### **NON-MAIN-TRACK COLLISION**

**BETWEEN CANADIAN NATIONAL TRAIN Q121-11-03  
AND VIA RAIL CANADA INC. TRAIN P614-21-02  
MILE 1.3, CANADIAN NATIONAL BEDFORD SUBDIVISION  
HALIFAX, NOVA SCOTIA  
03 JULY 2008**

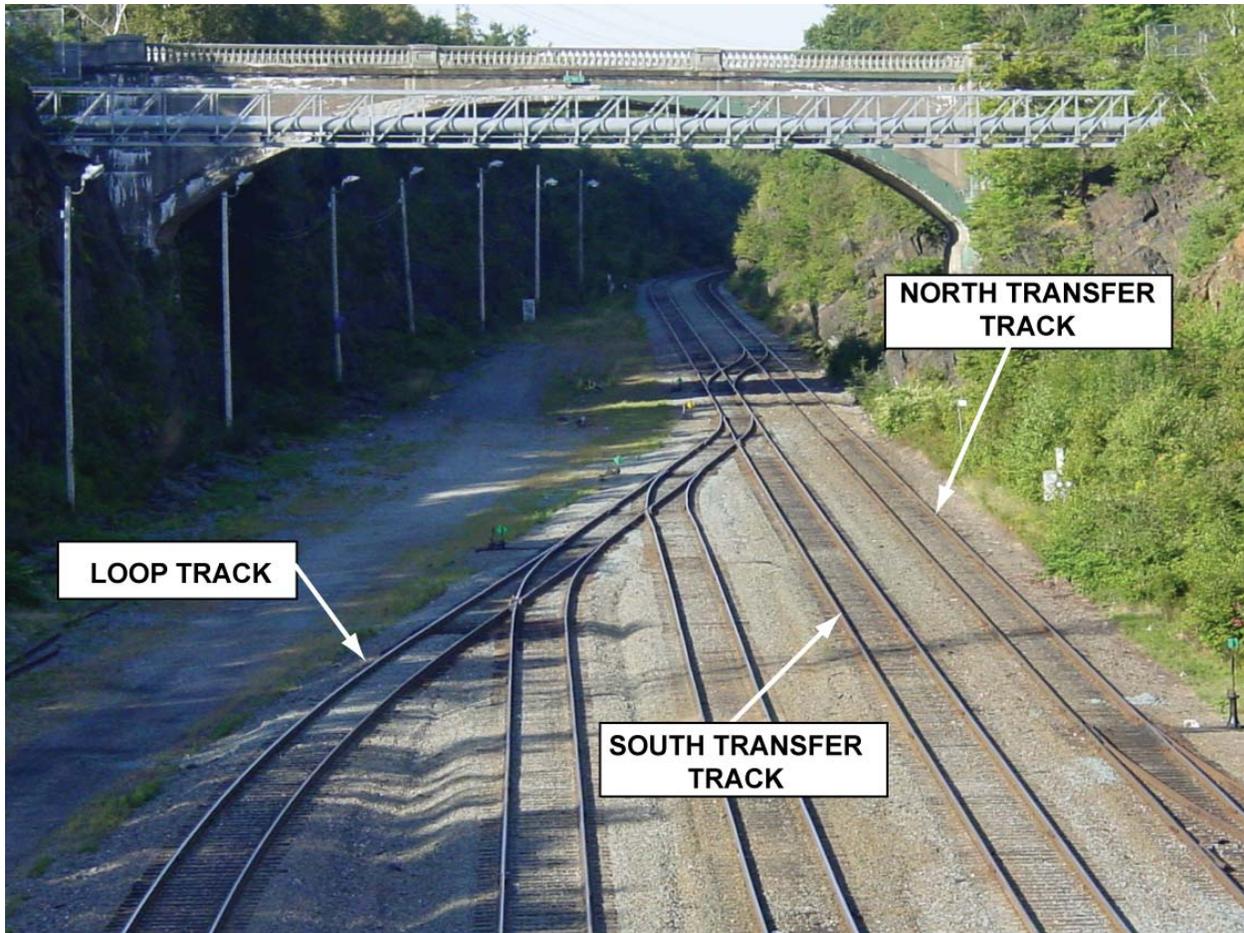
**Photo 2.** View westward showing lead from loop track on left and transfer tracks (south and north) on right

After its arrival at the station, the VIA train reversed westward on the north transfer track (see Photo 2) and entered the loop track at HOT. After completing the loop, the VIA train came back towards the north transfer track because the switches were already lined. The crew planned to stop and reverse eastward on the south transfer track into the Halifax VIA station. The VIA conductor remained at the east end of the train, in order to restore the derail for the loop track and to line the switches.
