Collision between OC Transpo bus and VIA passenger train: Executive summary

This summary of the Transportation Safety Board of Canada's (TSB) Railway Investigation Report R13T0192 contains a description of the accident, an overview of the analysis, findings, and safety action taken to date, as well as the five key recommendations that highlight what more needs to be done to help ensure an accident like this does not happen again.

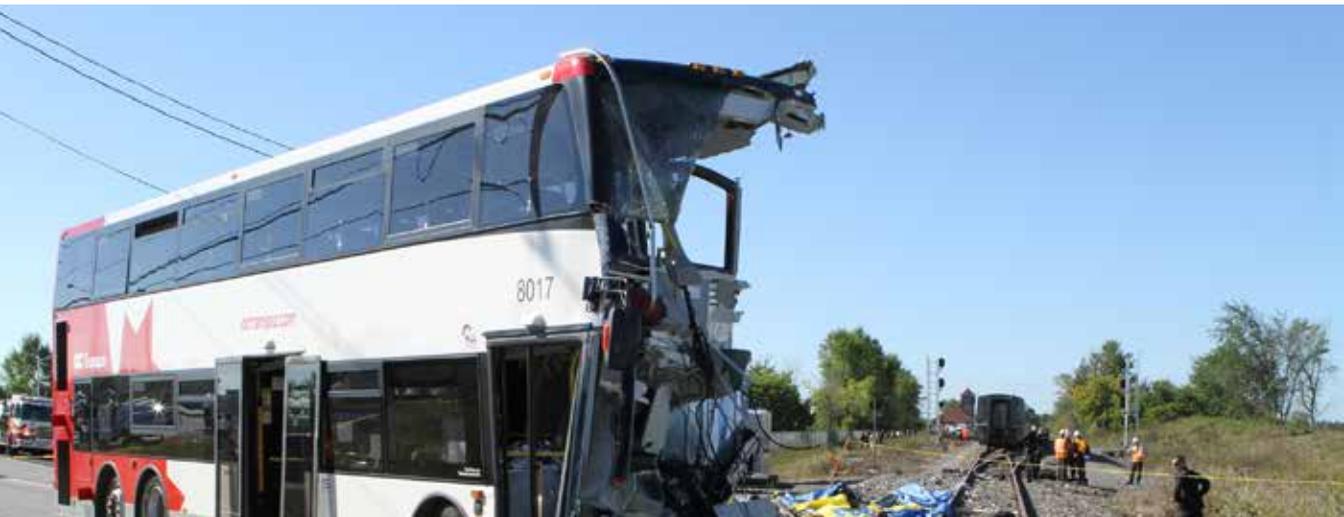
At about 0847:57, the driver was busy negotiating the left-hand curve ahead as some passengers continued conversations regarding the availability of seating on the upper deck. During this period, the driver looked upward and to the left toward the video monitor.

Meanwhile, VIA passenger train No. 51, which was heading west to Toronto, was approaching the Woodroffe Avenue and Transitway crossings. Although the crossing flashing lights, bells and gates had been activated more than 30 seconds earlier, the bells were not audible within the bus, and the driver's view of the gates and flashing lights was obstructed by trees, shrubs, foliage, Transitway signage, and the front corner pillars of the bus.

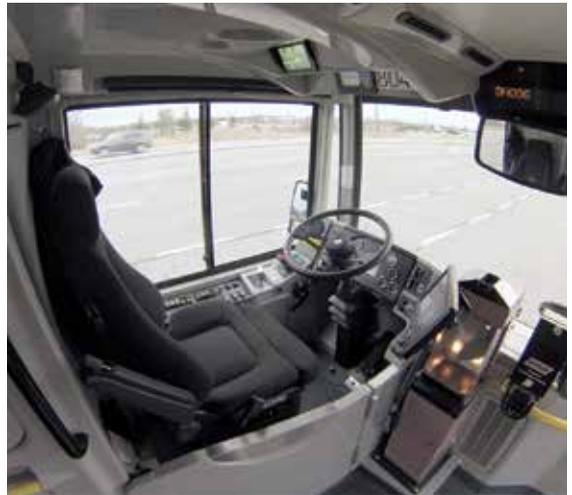
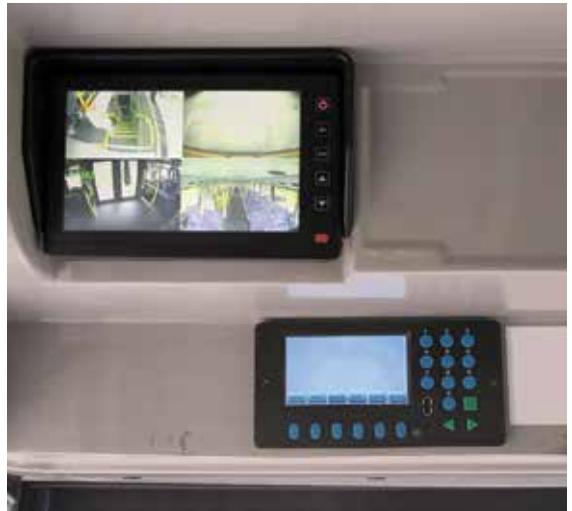
In 2013, the United States introduced driver distraction guidelines based on the principle that a driver should be looking at the road ahead rather than at an in-vehicle device. These guidelines, which are voluntary and apply only to light vehicles, include a recommendation to disable certain in-vehicle systems—such as video displays—unless a vehicle is parked. The guidelines also recommend that any active displays be positioned as close as practicable to the driver's forward line of sight.

Canada has no similar national standards or guidelines.
