**RAILWAY INVESTIGATION REPORT  
R14T0180**

**MAIN-TRACK TRAIN DERAILMENT AND COLLISION  
CANADIAN NATIONAL FREIGHT TRAIN M36831-01 AND  
VIA RAIL CANADA INC. PASSENGER TRAIN NO. 47  
MILE 153.92, KINGSTON SUBDIVISION  
GANANOQUE, ONTARIO  
01 AUGUST 2014**

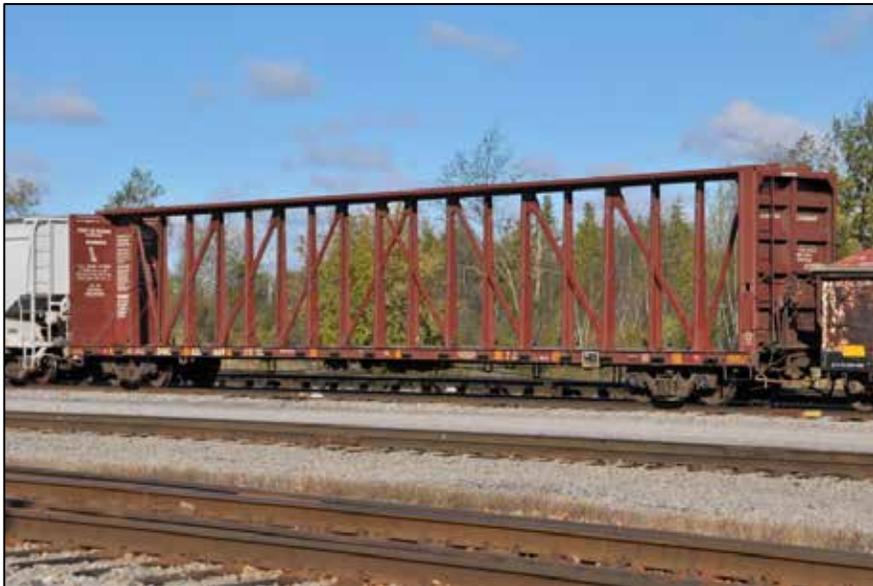
Photo 2. Centre beam bulkhead flat car similar to car GTW 623373 (Source: Ian A. McCord)

Centre beam bulkhead flat cars are approximately 80 feet long and relatively light when empty (Photo 2). This car type is designed with a bulkhead at each end to prevent loads from shifting and a centre beam integrated into the car centre sill to secure loads. This car type is less torsionally rigid than other types of cars, and is known to be more susceptible to truck hunting when empty.

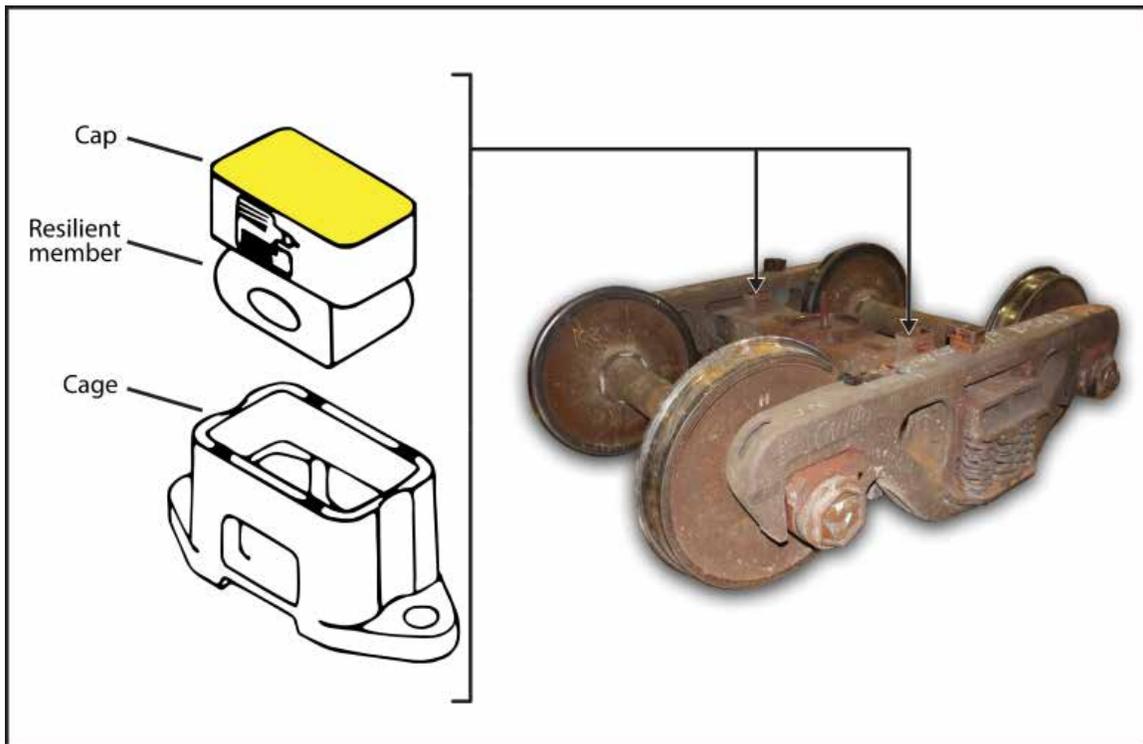
Figure 4. Miner standard travel constant contact side bearings

Car GTW 623373 was equipped with standard Barber S2 trucks that had Miner standard travel (ST) CCSBs installed. This type of CCSB is composed of 1 resilient member, a metal cap and a cage (Figure 4).

Car repair records indicate that on 24 October 2006, another railway replaced worn A-end friction castings. There is no indication that the CCSB components were inspected or replaced at that time.

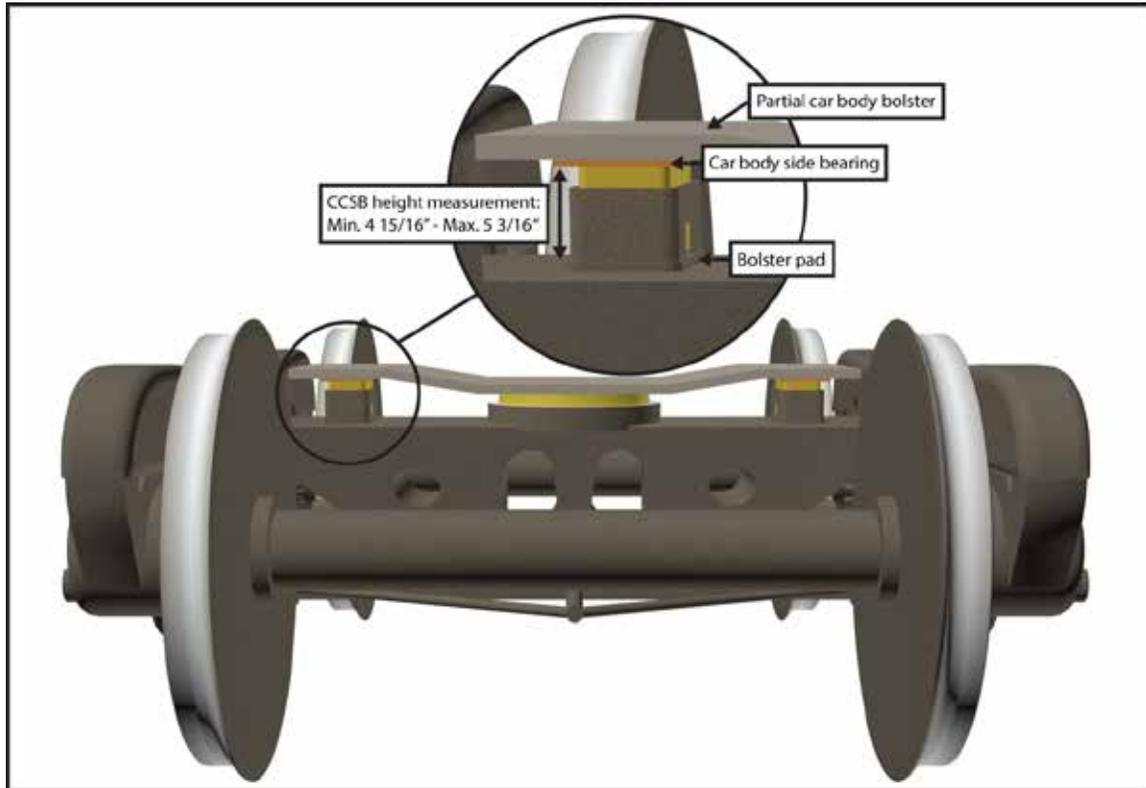
Figure 5. Single constant contact side bearing (CCSB) height measurement

- CCSBs are condemnable at any time should the resilient member be missing or exhibit heat damage (Rule 62 A 1.d), or should the sum-of-pairs height measurement<sup>17</sup> be less than 9¾ inches or greater than 10½ inches (Rule 62 A 1.h. (1)).
- CCSBs are condemnable when the car is on a shop or repair track should the resilient member exhibit damage (Rule 62 A 2.b),<sup>18</sup> or should the height for a single CCSB be less than 4<sup>15</sup>/<sub>16</sub> inches or greater than 5<sup>3</sup>/<sub>16</sub> inches (62 A 2.a(1)) (Figure 5).
- Damaged resilient members should be replaced in kind with new members.<sup>19</sup>
