RAILWAY INVESTIGATION REPORT

R16W0059

Uncontrolled movement of railway equipment

Cando Rail Services

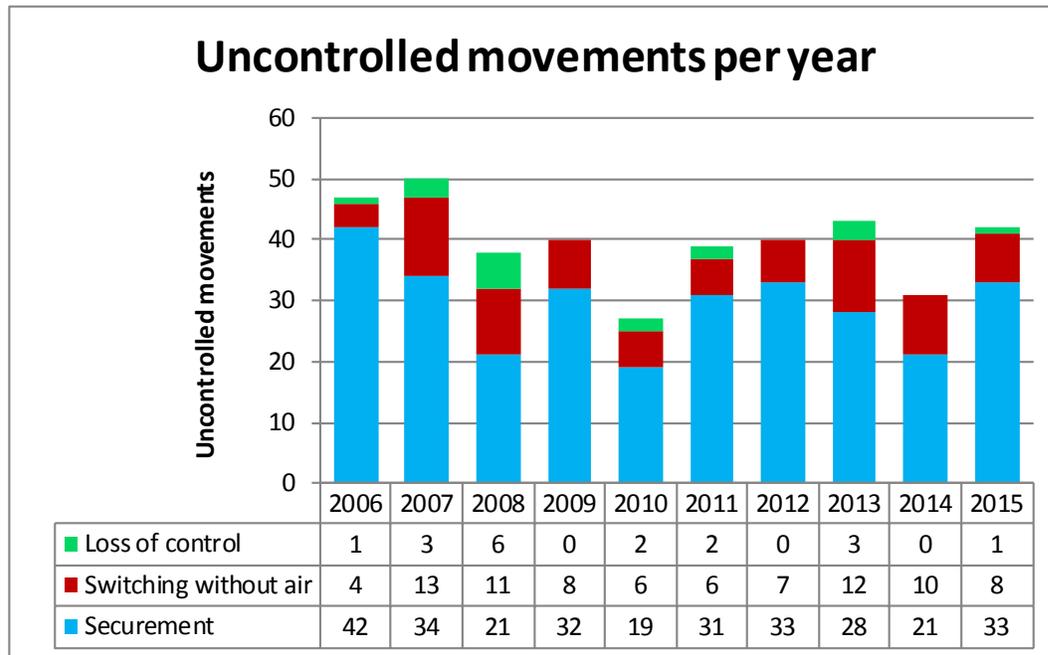
Figure 4. Occurrences defined as uncontrolled movements, 2006–2015

A search of the TSB database indicates that, since 2006, there have been 397 occurrences defined as uncontrolled movement⁸ among all railways in Canada (Figure 4).
