# RAIL TRANSPORTATION SAFETY INVESTIGATION REPORT R23D0108

## MAIN TRACK COLLISION AND DERAILMENT

Canadian National Railway Company freight train X37631-20 and  
Réseau de transport métropolitain (exo) commuter train EXO 1212  
Mile 135.89, St-Laurent Subdivision  
Montréal, Quebec  
21 November 2023

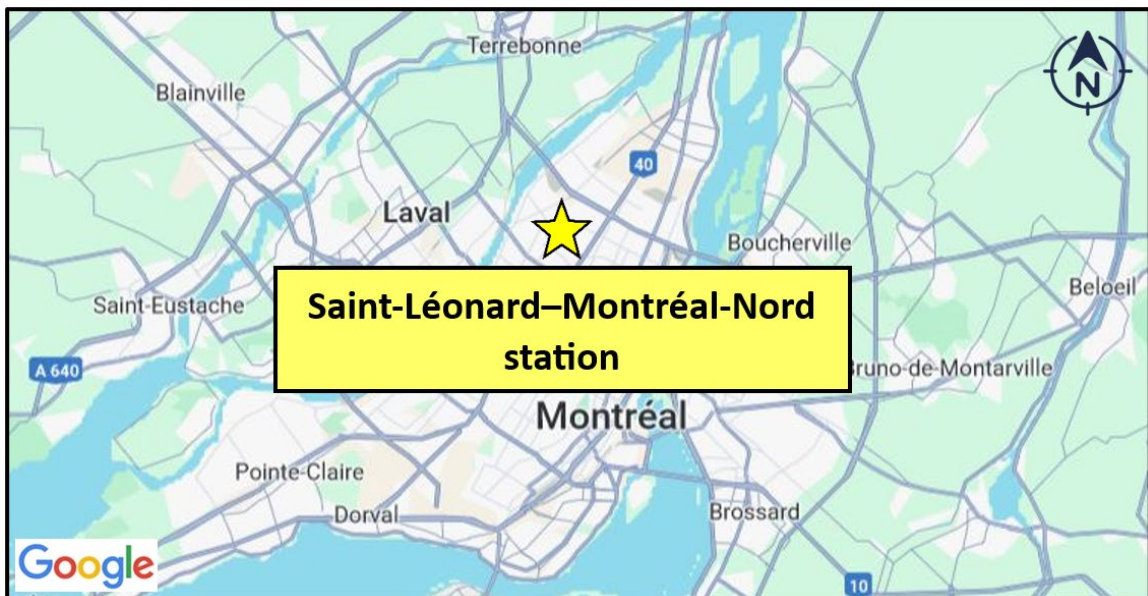
Figure 1. Map of the occurrence site (Source: Google Maps, with TSB annotations)

At approximately 1813, train EXO 1212, travelling southward on the east main track of the St-Laurent Subdivision, passed the CN Rivière-des-Prairies Yard. The train consisted of 3 Bombardier multilevel cars, namely a control car<sup>4</sup> and 2 passenger cars,<sup>5</sup> and a diesel-electric locomotive<sup>6</sup> coupled to the tail end. It weighed approximately 335 tons and was about 313 feet long. Eight passengers and 2 crew members were on board. The train was controlled by the LE from the operating cab of the control car while the conductor was on board car EXO 3062. The train was bound for its next stop, Saint-Léonard–Montréal-Nord station in Montréal, Quebec (Figure 1).

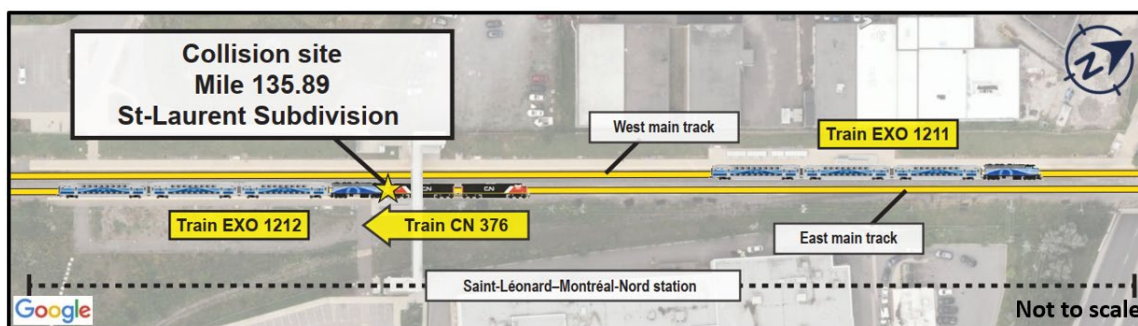
Figure 2. Collision site (Source: Google Maps, with TSB annotations)

After meeting train EXO 1211, the LE of train CN 376 switched the locomotive's headlights back to full power. He then spotted the tail end of train EXO 1212 (locomotive EXO 1346) stopped on the same track, about 500 feet ahead. The LE immediately made an emergency application of the train brakes while the train was travelling at approximately 41 mph. Train CN 376 had slowed to approximately 32 mph when it collided with train EXO 1212 (Figure 2), at approximately 1827.

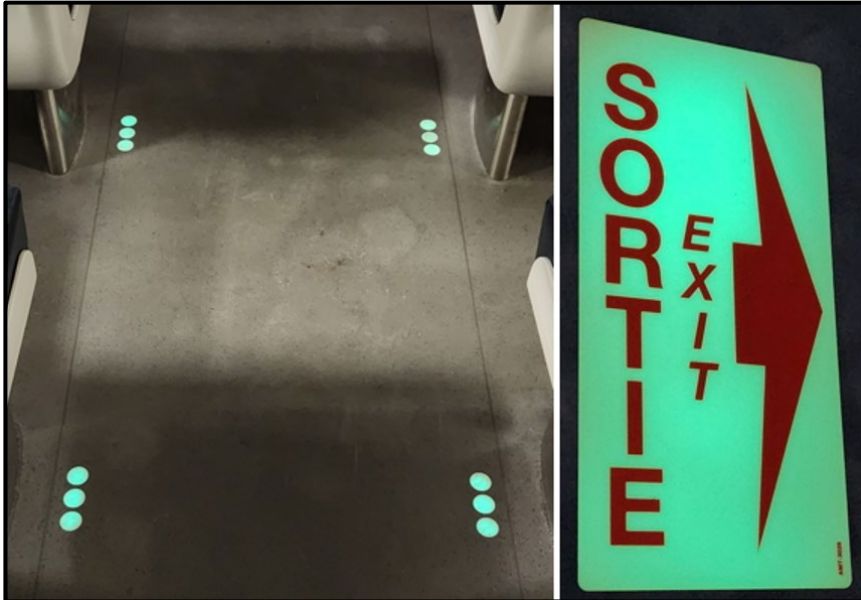
Figure 5. Luminescent signage on board exo cars (Source: TSB)

After the collision, the passengers on board train EXO 1212 were evacuated to the station platform via the car doors that were already open. With no emergency lighting, which was disabled in 2 of the 3 cars (car EXO 3062 and control car EXO 3008), passengers were guided in the dark by onboard luminescent signage (Figure 5).

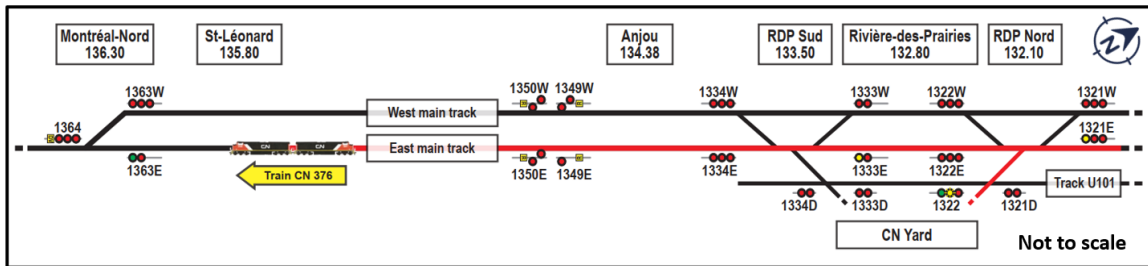
Figure 7. Train CN 376 route between Rivière-des-Prairies Yard and the collision site (Source: TSB)

When train CN 376 left CN’s Rivière-des-Prairies Yard, it passed by 4 CTC signals on its way to Saint-Léonard–Montréal-Nord station (Figure 7):

- The 1st signal, 1322, displayed a “Slow to Medium”<sup>21</sup> indication, allowing the train to exit the yard northward onto the east main track of the St-Laurent Subdivision.
- The 2nd signal, 1321E, displayed a “Clear to Stop”<sup>22</sup> indication, allowing the train to reverse direction and head south.
- The 3rd signal, 1333E, which had previously indicated “Stop,”<sup>23</sup> changed to display a “Clear to Stop” indication, allowing the train to continue southward.
- The 4th signal, 1349E displayed a “Restricting” indication, allowing the train to proceed at the restricted speed.

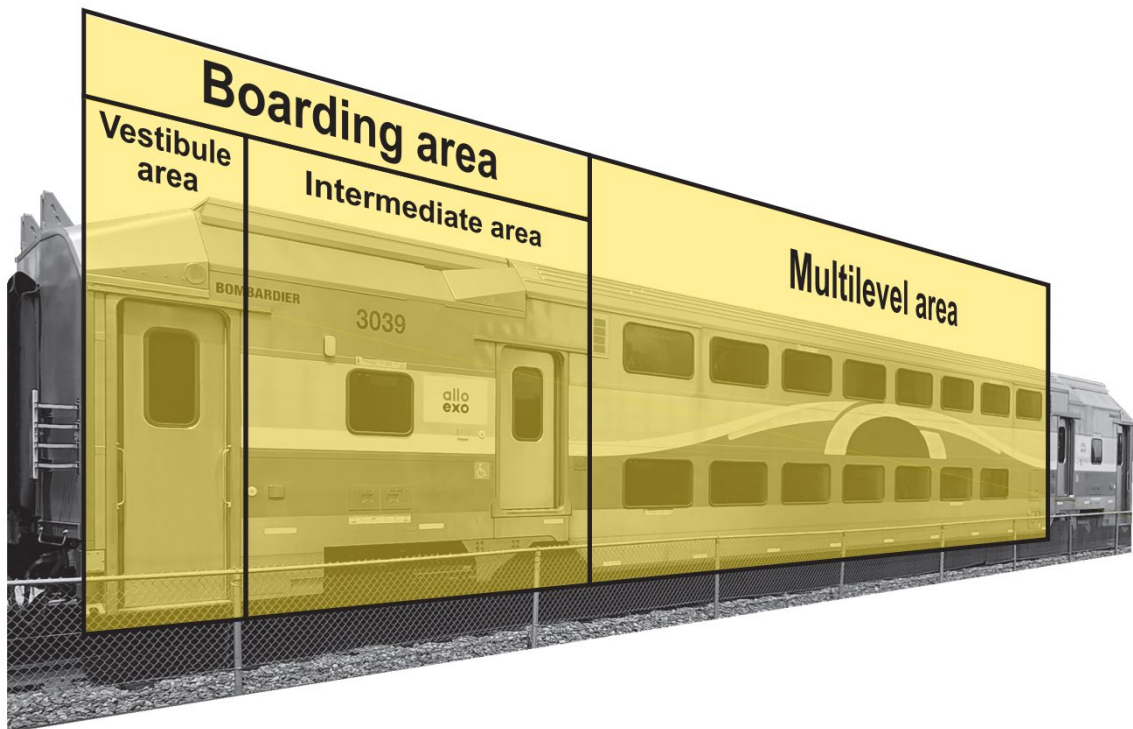
Figure 10. Zones of an exo multilevel car (Source: TSB)

collision, the ends of the cars must collapse before the multilevel passenger area between the body crossmembers and the boarding area (Figure 10).
