Air Transportation Safety Investigation Report A17C0147

COLLISION WITH TERRAIN

Piper PA-23-250 Aztec, C-FIPK
Baldur, Manitoba, 5 nm E
15 December 2017

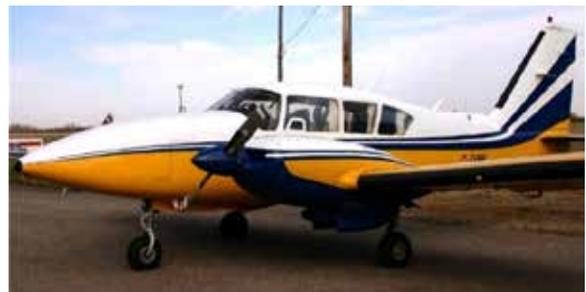
Figure 1. C-FIPK (Source: Luc Brousseau)

On 15 December 2017, the privately registered Piper PA-23-250 Aztec (registration C-FIPK, serial number 27-8054059) (Figure 1) was conducting a visual flight rules flight from Gillam Airport (CYGX), Manitoba, to an unlighted private aerodrome located 5.25 nautical miles (nm) east of Baldur, Manitoba, with only the pilot on board (Figure 2).
