RAILWAY INVESTIGATION REPORT

R01E0009

DERAILMENT

CANADIAN PACIFIC RAILWAY

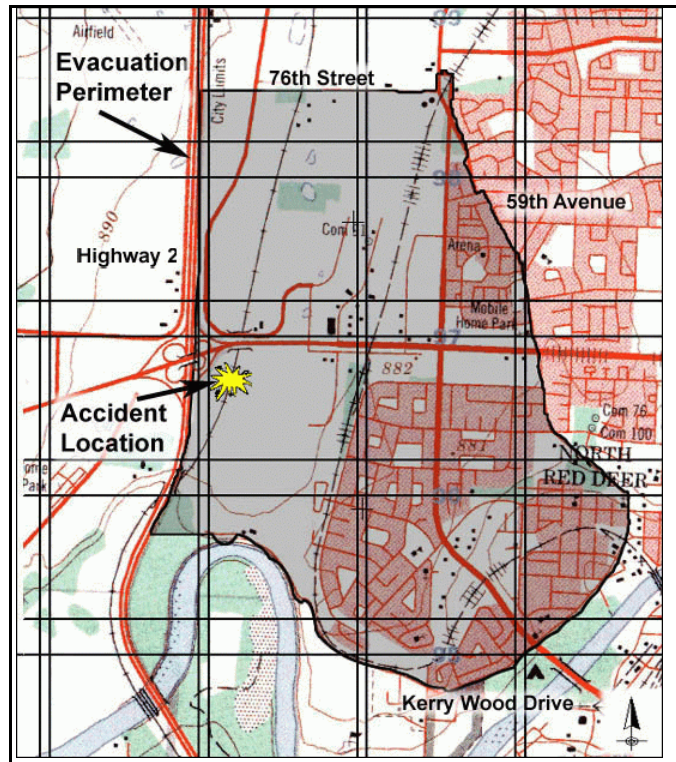
The locomotive engineer consulted the *2000 Emergency Response Guidebook* for the properties of and the proper response to anhydrous ammonia. Upon identifying the potential hazards, he disconnected the locomotive from the rail cars and departed from the scene. The conductor immediately went to the CPR yard office, located approximately 1500 feet from the overturned cars, to alert management and employees to the situation. Figure 2 shows the derailed and overturned ammonia tank cars.
