AVIATION INVESTIGATION REPORT

A99P0056

MID-AIR COLLISION

108 MILE AIRPORT, BRITISH COLUMBIA

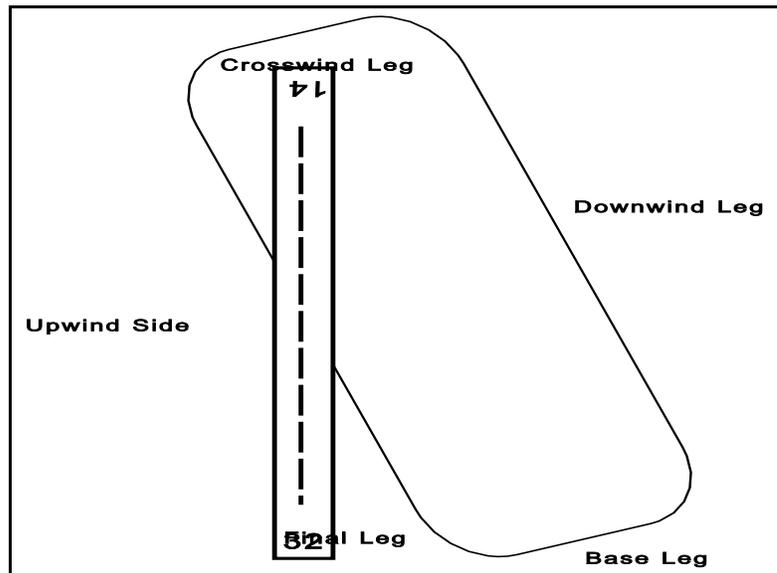
*A.I.P. Canada*, published by Transport Canada (TC), prescribes the procedures that pilots should follow when operating at an uncontrolled airport. These procedures are widely distributed and establish a fundamental basis for safe aircraft operations in Canada. Prior to joining a traffic circuit, all pilots should announce their intentions. Where no mandatory frequency (MF) procedures are in effect, aircraft should approach the traffic circuit from the upwind side or, once having ascertained without any doubt that there will be no conflict with other traffic entering the circuit or established within the circuit, the aircraft may join the circuit on the downwind leg. There are no MF procedures in effect at 108 Mile Airport. Designation of an ATF is aimed at ensuring that all radio-equipped aircraft operating on the ground or within the specified ATF area are listening on a common frequency and following common reporting procedures.

*Canadian Aviation Regulations* require that all turns be to the left while operating in the circuit, unless a right-hand circuit has been specified in the *Canada Flight Supplement* (CFS). The CFS specifies right-hand circuits for runway 32 at 108 Mile Airport during daylight hours.
