MARINE INVESTIGATION REPORT
M04W0225

CAPSIZING

FISHING VESSEL *PROSPECT POINT*
TAHSISH INLET, KYUQUOT SOUND, BRITISH COLUMBIA
29 OCTOBER 2004

Report Number M04W0225

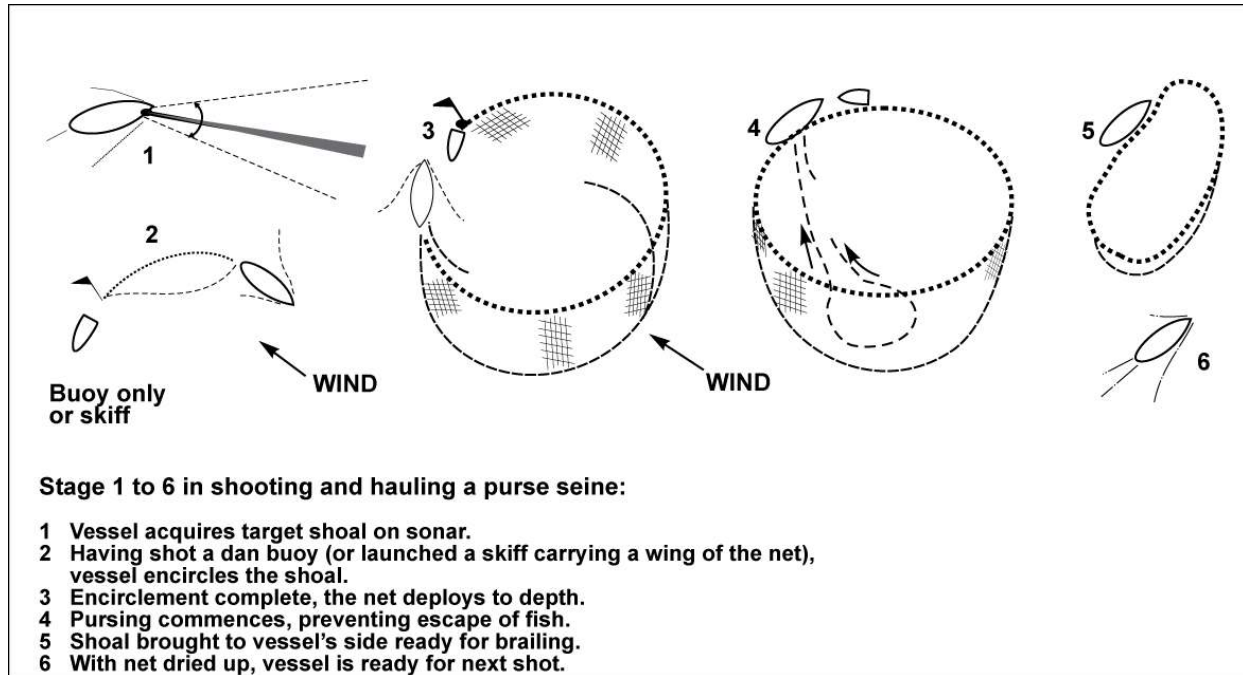
Figure 1. Sketch showing six stages in shooting and hauling purse seine

Purse seining is a method used to catch schooling fish near the ocean surface by encircling them with a net. Once the fish have been encircled, a wire (purse line) running through the bottom of the net is winched tight to “close the purse” from below.

When setting the net, a power skiff secures to the free end of the 410 m long net, then draws it off the seine drum and away from the fishing vessel (seiner). The upper edge of the net is buoyed with floats and remains on the surface. Approximately 35 m below the surface, the lower edge of the net is weighted so that it is suspended vertically in the water. Metal rings connect the “purse line” to the lower edge of the net.

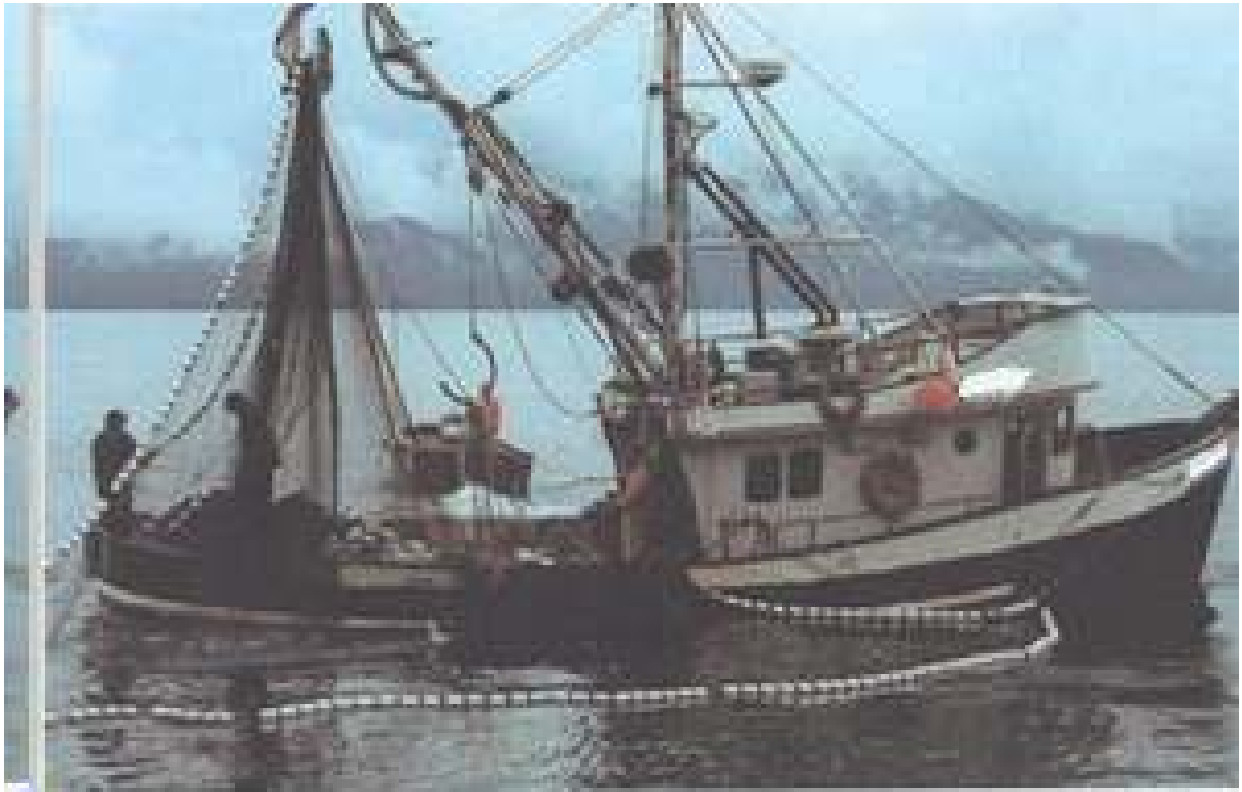
Photo 1. Photo of a fishing vessel engaged in purse seining
