**MARINE INVESTIGATION REPORT
M12L0098**

RISK OF COLLISION

**BULK CARRIER *BULK JAPAN* AND
TUG *WILF SEYMOUR* WITH BARGE *ALOUETTE SPIRIT*
GULF OF ST. LAWRENCE, QUEBEC
06 AUGUST 2012**

Report Number M12L0098

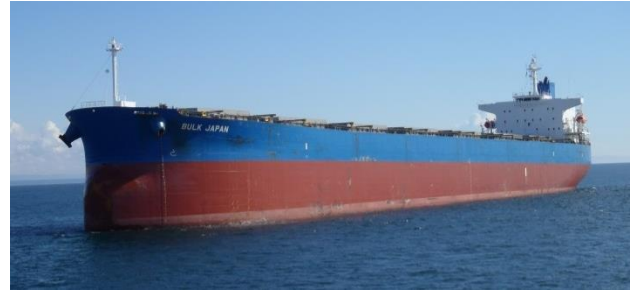
Photo 1. *Bulk Japan*

The *Bulk Japan* is a bulk carrier cargo vessel of steel construction with machinery spaces and accommodations located aft (Photo 1). The vessel is gearless² and is fitted with 7 cargo holds

and hatches. The bridge is fitted with the required navigational equipment. The navigation console is offset from the bridge front wall and includes the steering wheel, which is on the centreline, and a telegraph from which the propulsion can be controlled. The navigation console also comprises of the vessel's 2 radars (3 cm and 10 cm) situated to the left of the steering wheel; both are fitted with automatic radar plotting aids (ARPA).

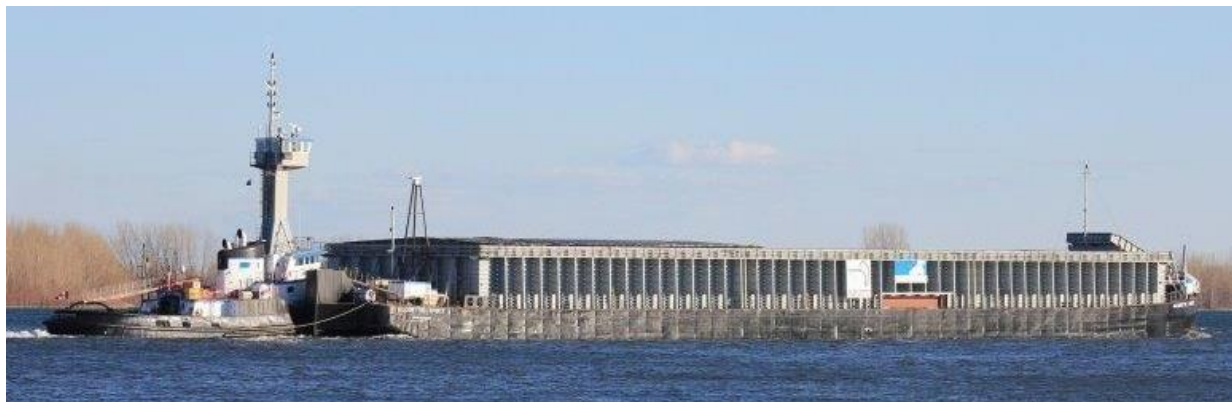
Photo 2. *Wilf Seymour and Alouette Spirit*

At the time of the occurrence, the vessel was operating with the barge *Alouette Spirit* as an integrated tug/barge unit (Photo 2). The *Alouette Spirit* is a ro-ro/lo-lo³ multi-purpose barge capable of carrying a wide range of bulk and general cargo on the deck. The barge is equipped with a built-in bow ramp and a bow thruster that is controlled remotely from the tug for enhanced manoeuvrability. The barge has a retractable canopy roof that shields cargo from the elements and 2 side doors, 1 on either side of the vessel, for loading and discharging. The *Alouette Spirit's* cargo capacity is 10 500 tonnes.
