# RAILWAY INVESTIGATION REPORT R16T0111

# Uncontrolled movement of railway equipment

Canadian National Railway Company Remote control locomotive system 2100 west industrial yard assignment Mile 23.9, York Subdivision MacMillan Yard Vaughan, Ontario 17 June 2016

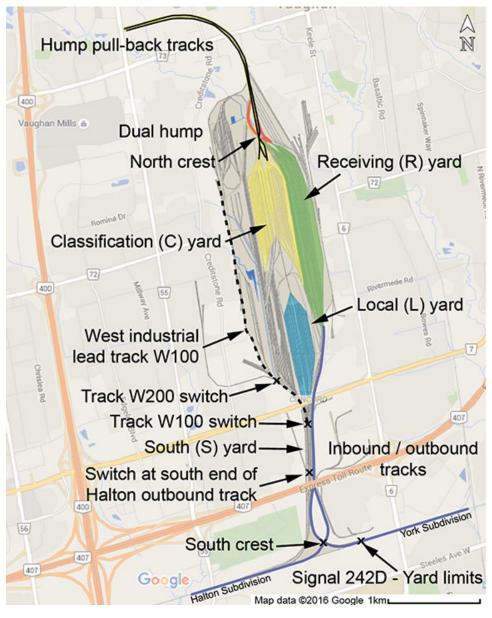
Figure 2. Layout of Canadian National Railway Company MacMillan Yard (Source: Google Maps, with TSB annotations)

MacMillan Yard (Figure 2) is CN's main classification yard in Eastern Canada, where rail traffic is distributed by flat switching or "humping"<sup>2</sup> rail cars into various tracks for placement on different trains. MacMillan Yard operations are conducted under *Canadian Rail Operating Rules* (CROR) Rule 105. Train movements are restricted to speeds of up to 15 mph and must be able to stop within half the range of vision of equipment. The yard processes up

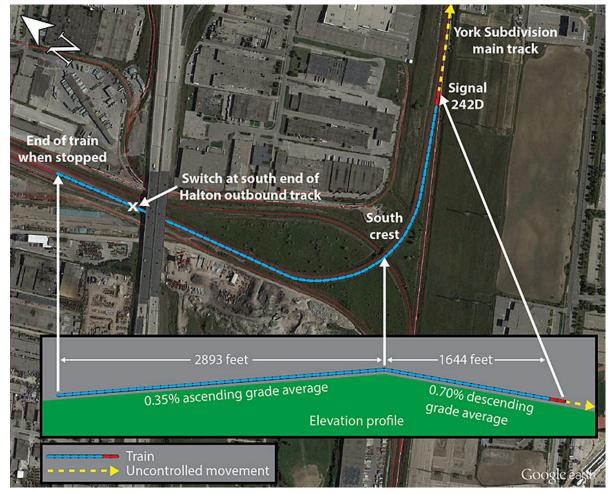
Yards are generally designed with a bowl-shaped profile to protect against freight cars rolling uncontrolled onto the main track during switching and/or humping operations. MacMillan Yard has a descending grade from both the north and south end of the tracks toward the centre of the yard, giving it such a bowl-shaped profile. At the south end of the yard, the south crest of the bowl is located 1644 feet west of Signal 242D (Figure 3), on top of the Halton Subdivision railway overpass. There is a 0.35% ascending grade for trains approaching the south crest from the north. There are no signs identifying the location of the south crest to train or assignment crews. Over the crest, there is an eastward 0.70% descending grade approaching Signal 242D and extending onto the York Subdivision.

Figure 3. Location of the assignment when stopped at Signal 242D and related track profile (Source: Google Earth, with TSB annotations)

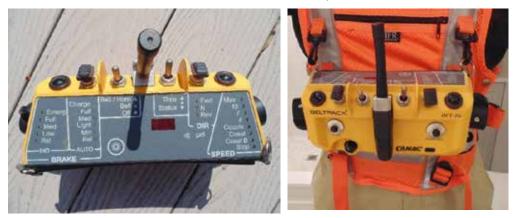
```
Figure 4. Operator control unit
```

Figure 5. Operator control unit attached to an operator's vest

Beltpack operators choose a pre-selected speed of up to 15 mph, after which the operator does not have to manipulate the controls, as the RCLS takes the required actions to reach and maintain that speed. The system applies either the throttle or the brakes of the locomotives to maintain the pre-selected speed at  $\pm$  0.5 mph. The system adapts to train and terrain characteristics reactively, without taking the train length, tonnage, or slack into account.
